## The 'Umka' landslide

We present an in-depth landslide map of the 'Umka' landslide near Belgrade, Serbia, at a scale of 1:5000. The map delineates elements at risk, primarily buildings and road infrastructure impacted by the landslide displacements of several cm per year, introduced during frequent reactivation stages. The Main map results from a survey of over 350 buildings and more than 7 km of state and local roads. The acquisition techniques included engineering geological field mapping, building survey, and visual interpretation of high-resolution UAV images. This is the first case of an integrated approach to mapping elements at risk within an urbanized active landslide in Serbia. Presently, over 490 people continue to reside at the site, facing daily landslide risks. This research and map hold substantial value for local authorities and decision-makers, providing a basis for conducting landslide risk analyses and implementing effective risk mitigation strategies or remedial measures.

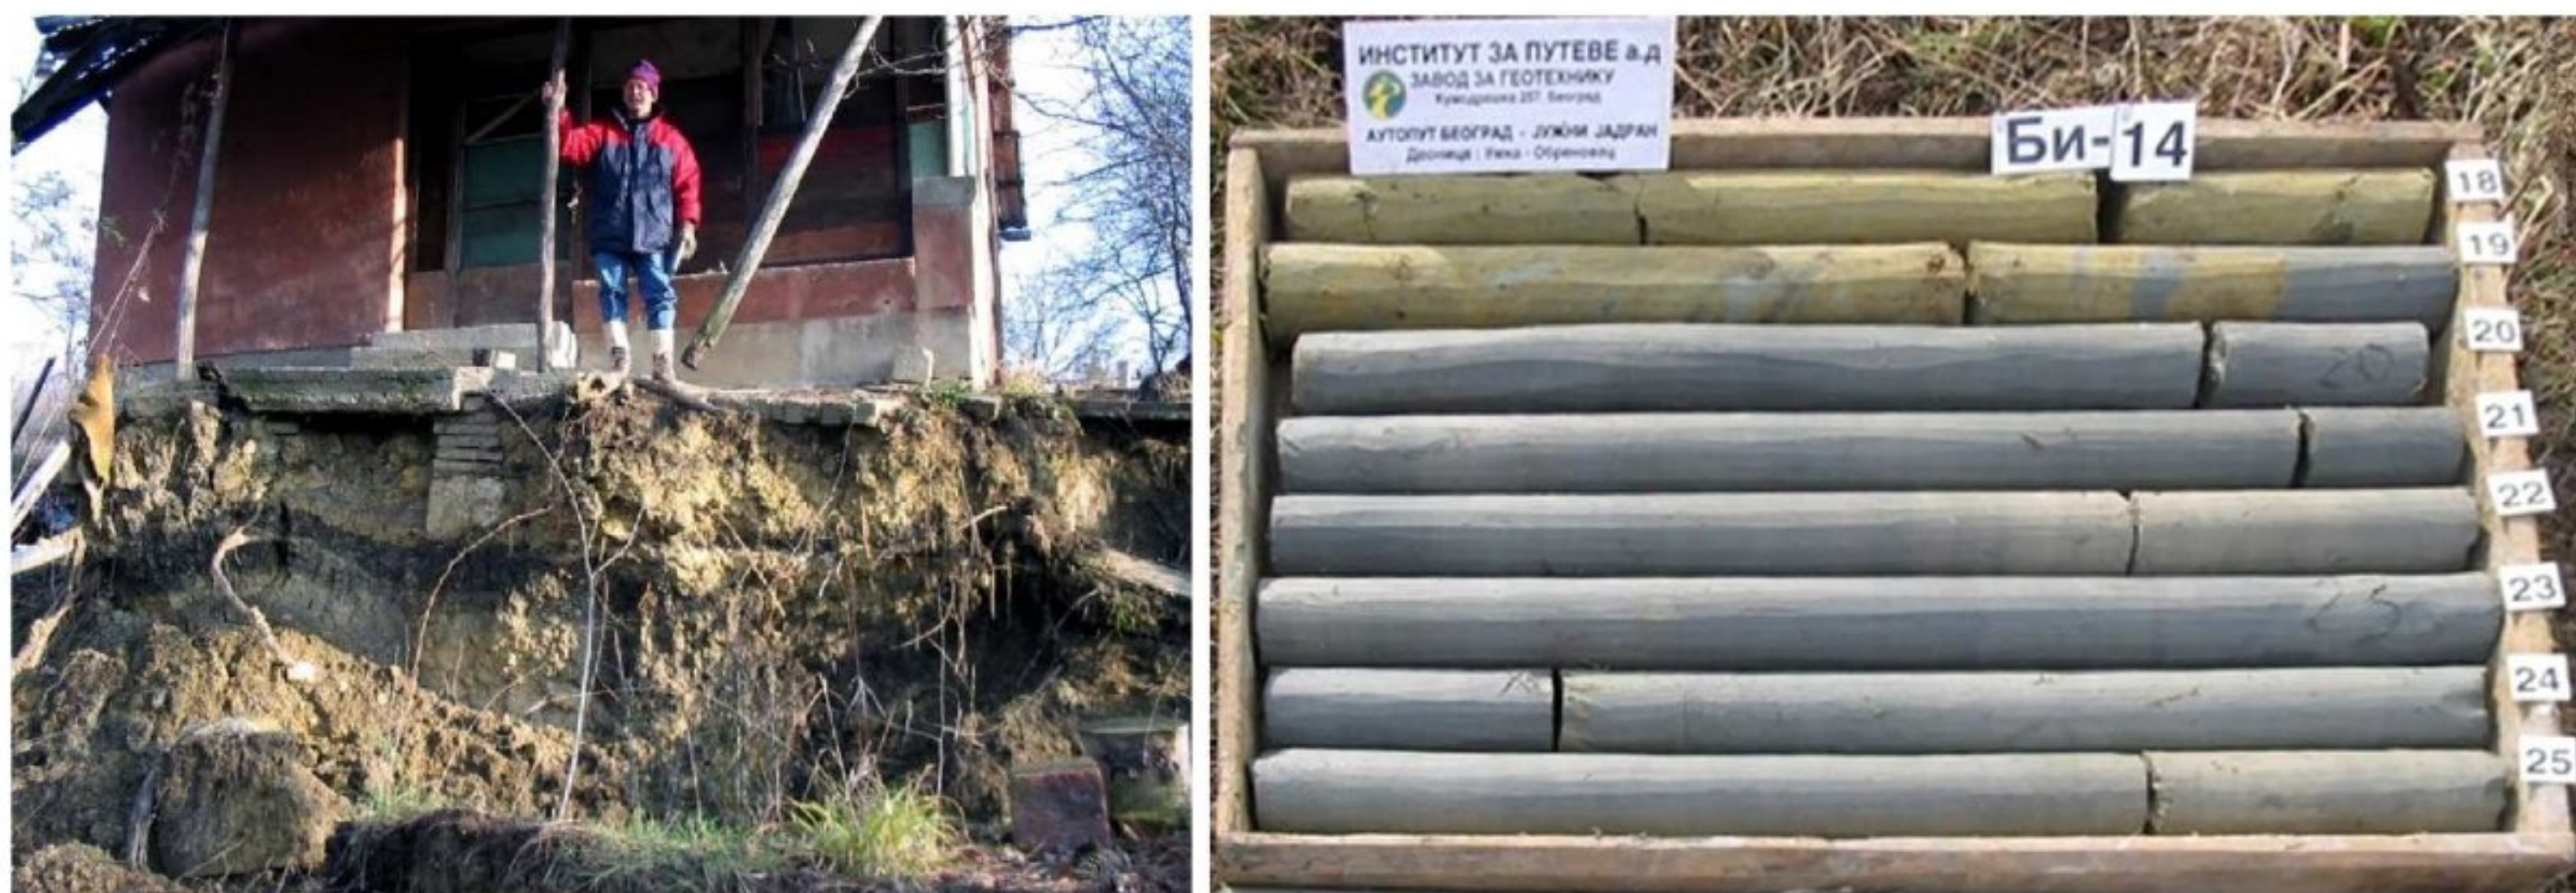
and their weathered and remoulded counterparts. The landslide named ‘Umka’ after the settlement itself, was primarily formed through the gravitational movement of certain portions of these sediments towards the Sava River, with a dominant WNW direction. The sliding process primarily affected decomposed, oxidized yellow Miocene marly clays ( $M_3^2$ ) and dark-brown, silty-sandy clays ( $d_{pr}$ ) of deluvial origin (Jelisavac et al., 2006). These marls are typically soft to firm and form the uppermost layers of the stratigraphic column, making them highly susceptible to sliding and deformation when disturbed by natural processes or human activities (Jelisavac et al., 2006). Beneath, the fresh grey marls ( $M_3^2L$ ) of unknown depth are forming the base, and typically are not involved in the sliding. In fact, it predominantly occurs in the interface of marly clays and marls (Figure 1).

**Figure 1.** Field images of outcrops on the face of a secondary landslide scar, with typical remolded material with heterogeneous lenses and undulating interfaces (left); and the core box of borehole Bi 14, where interface of fresh marl and remolded clay marl, representing the slip surface, is visible (right); Photo by Svetozar Milenković.

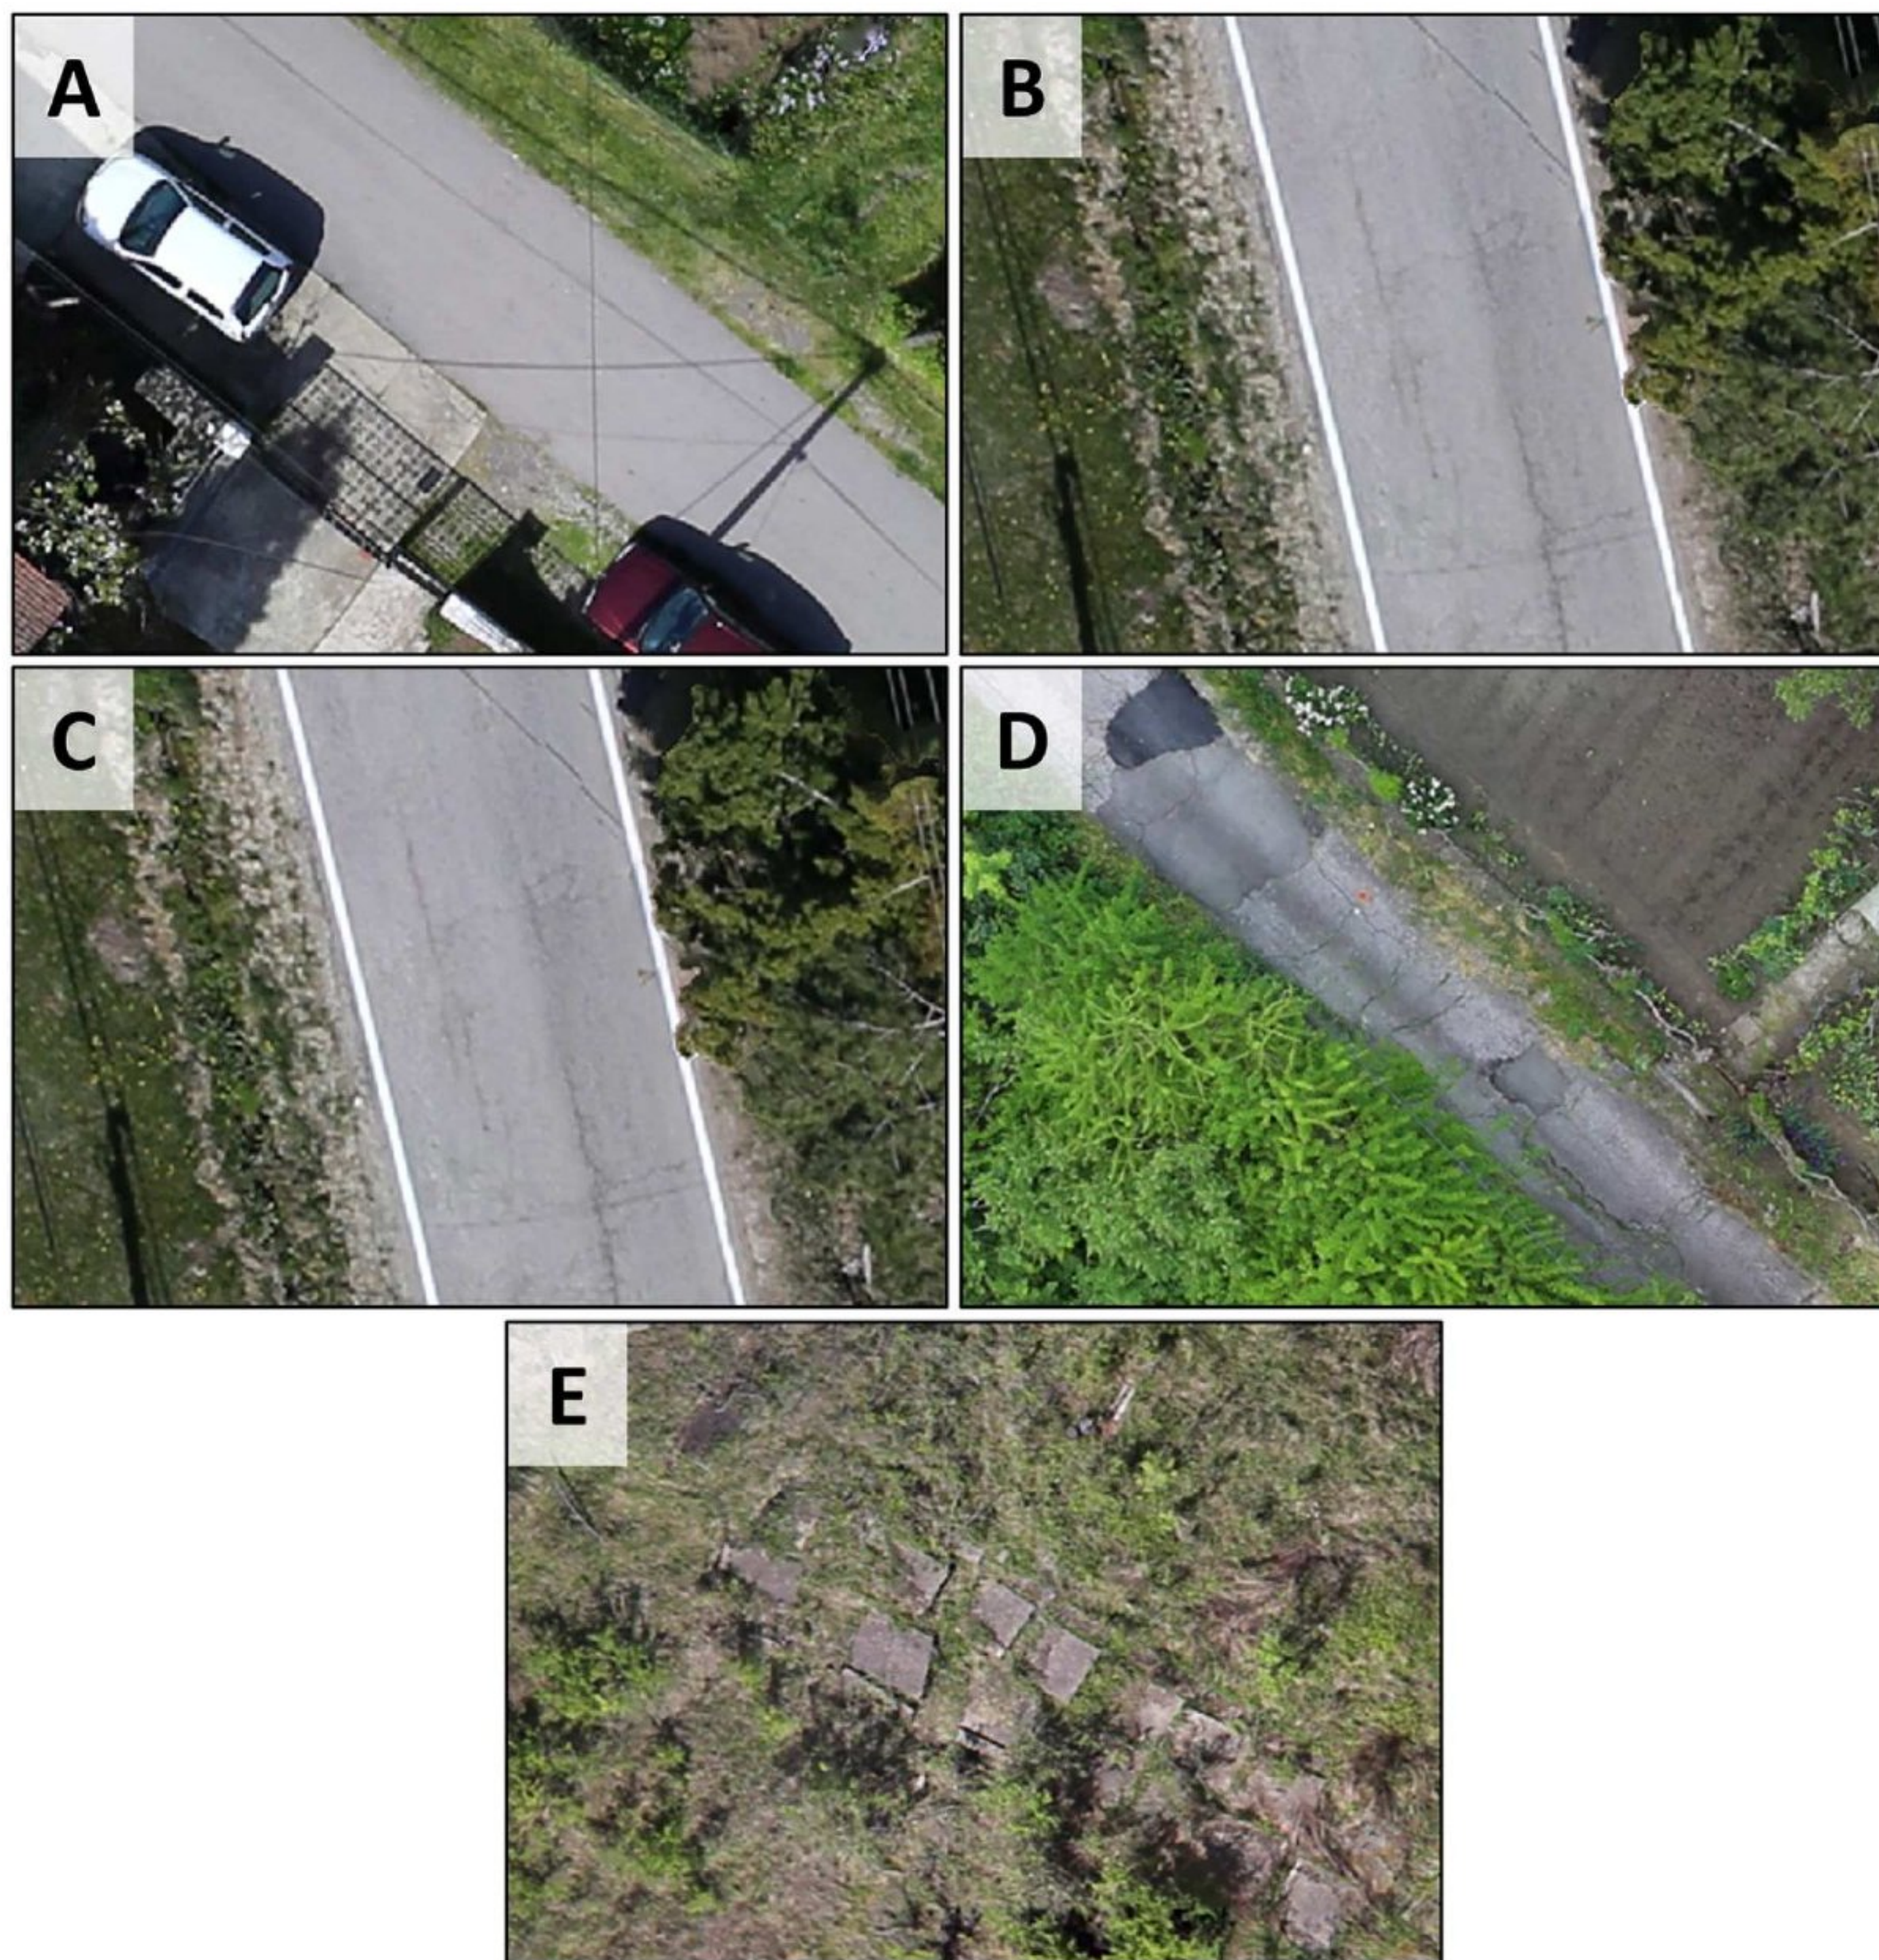
The categorization of damage was primarily based on the assessment of the actual road surface damage, which was visible from orthophotos (Figure 2). The condition of the road structure itself, which was only present on state road N°26, was verified through field inspections. Each road was divided into segments by deformation, ranging from 'no damage' to 'permanently destroyed', based on a qualitative description,

**Figure 2.** Details of roadway infrastructure based on the criteria outlined in Table 2: (A) Road without damage; (B) Slightly damaged road; (C) Damaged Road; (D) Heavily damaged road; (E) Destroyed Road.

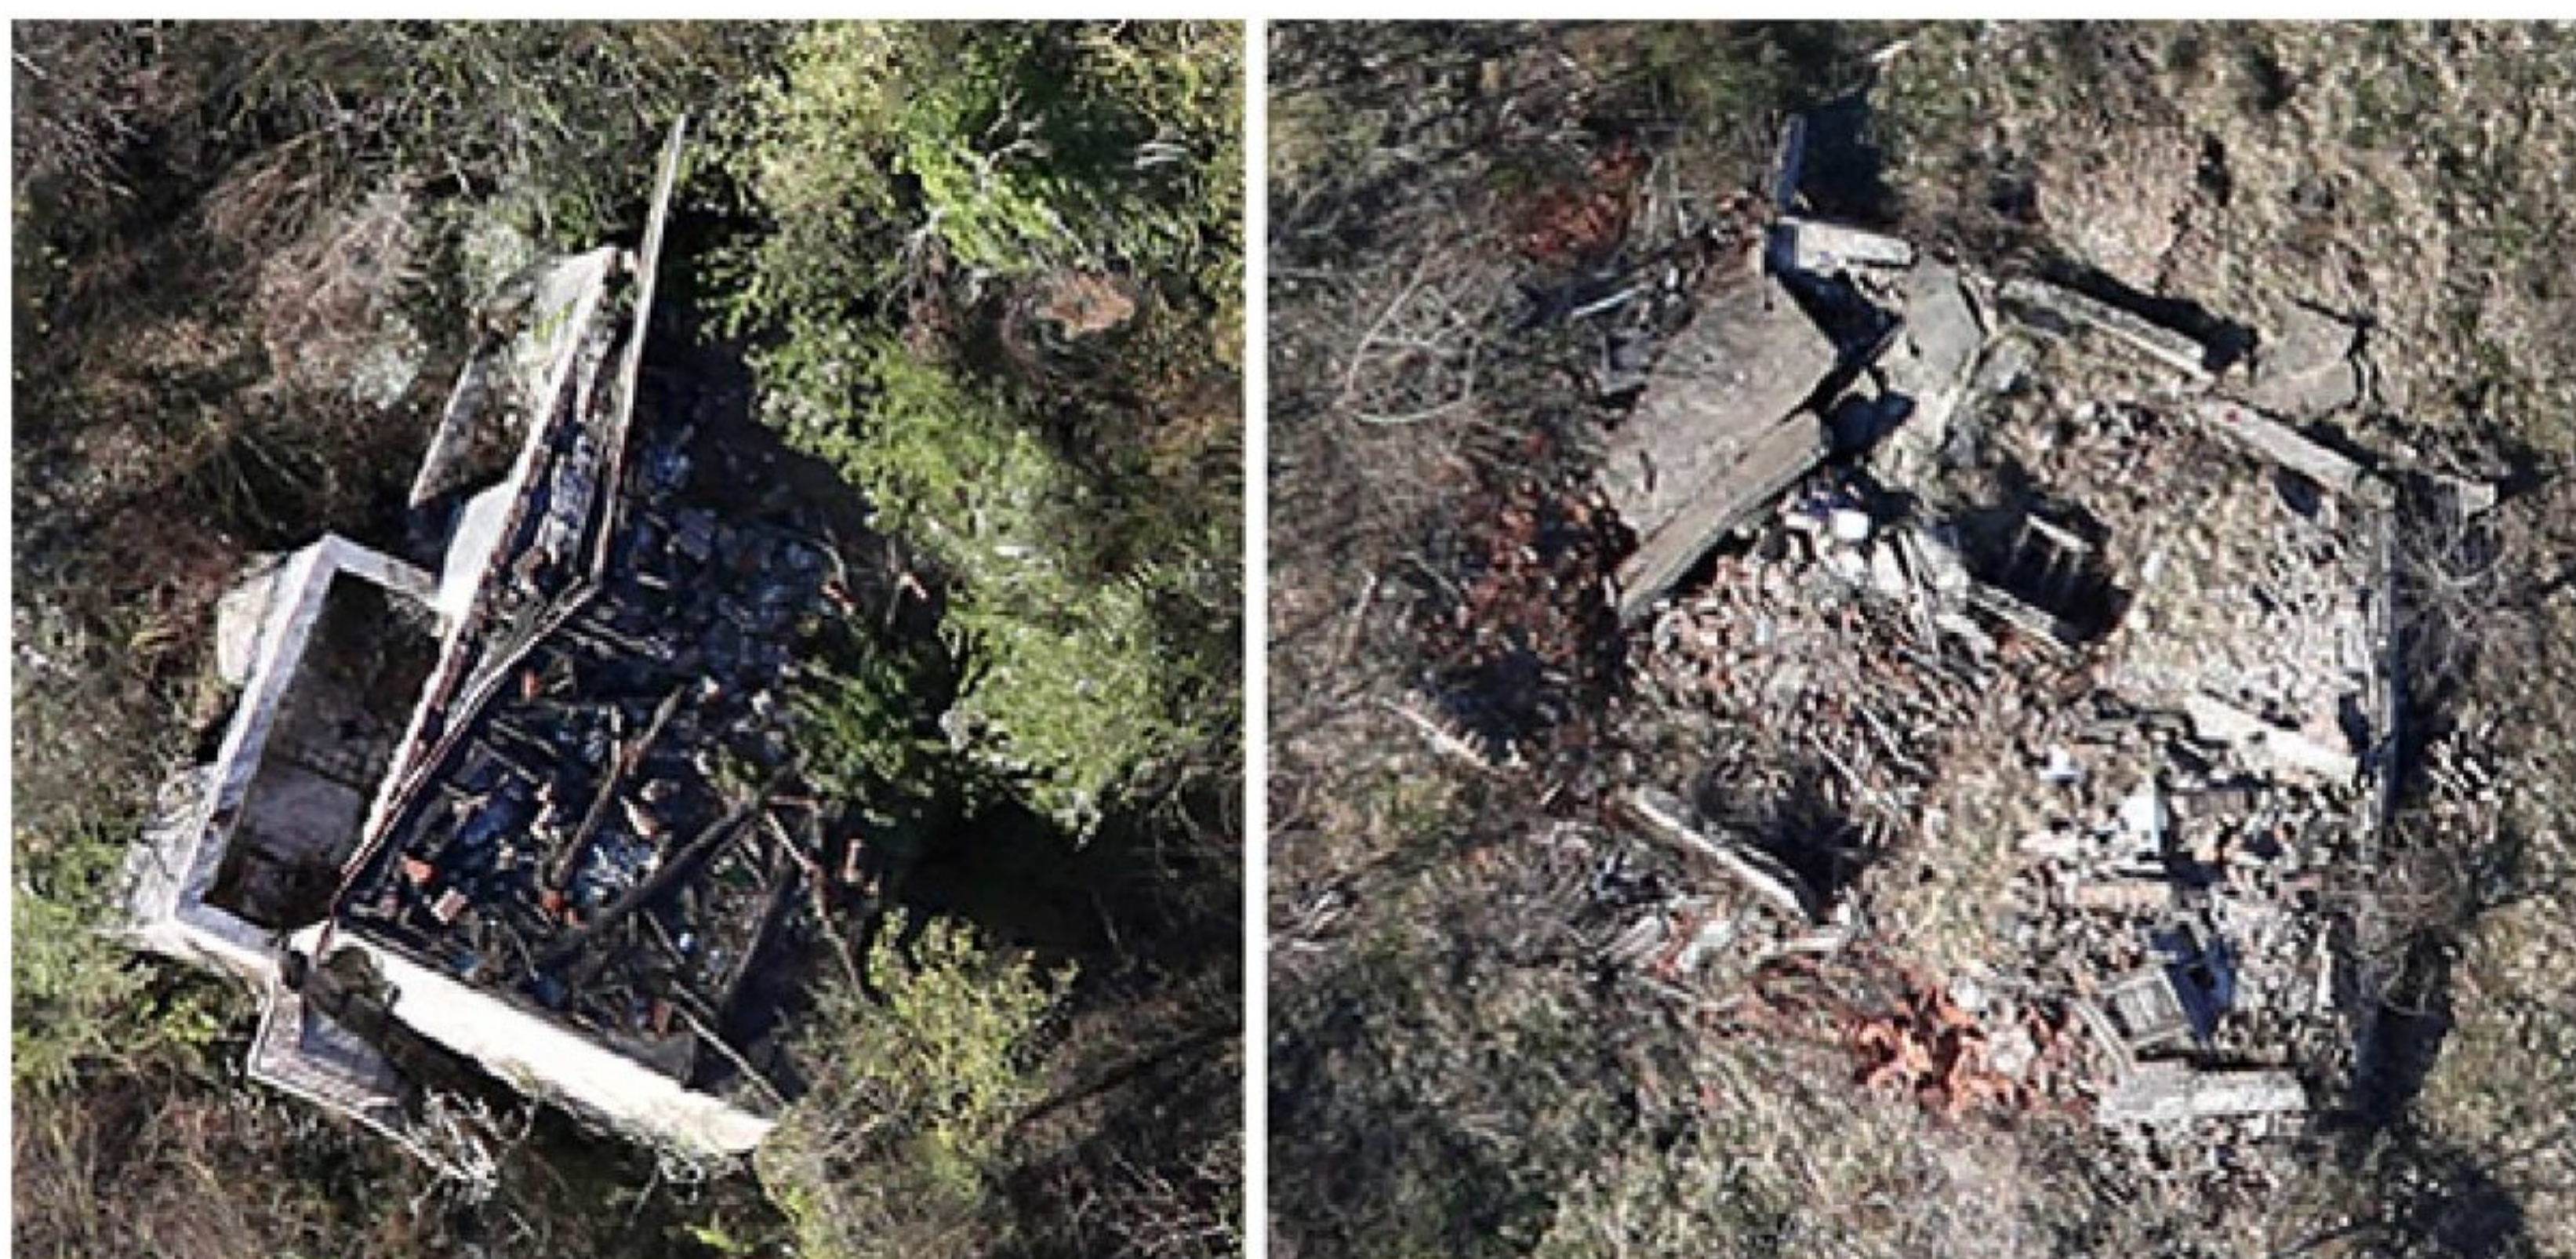
questionnaire was made. As many as 18 buildings in the landslide area are no longer physically located in their original positions. These buildings were mapped using remote sensing techniques (Figure 3), based on archival or newly captured aerial photographs. For these buildings, attributes were recorded to a level that was possible using only visual identification as a tool. For example, it was possible to recognize the type of roof covering, the useful square footage of the base of

**Figure 3.** Aerial images of two destroyed buildings on the 'Umka' landslide that are inaccessible and surveyed by UAV remote sensing.

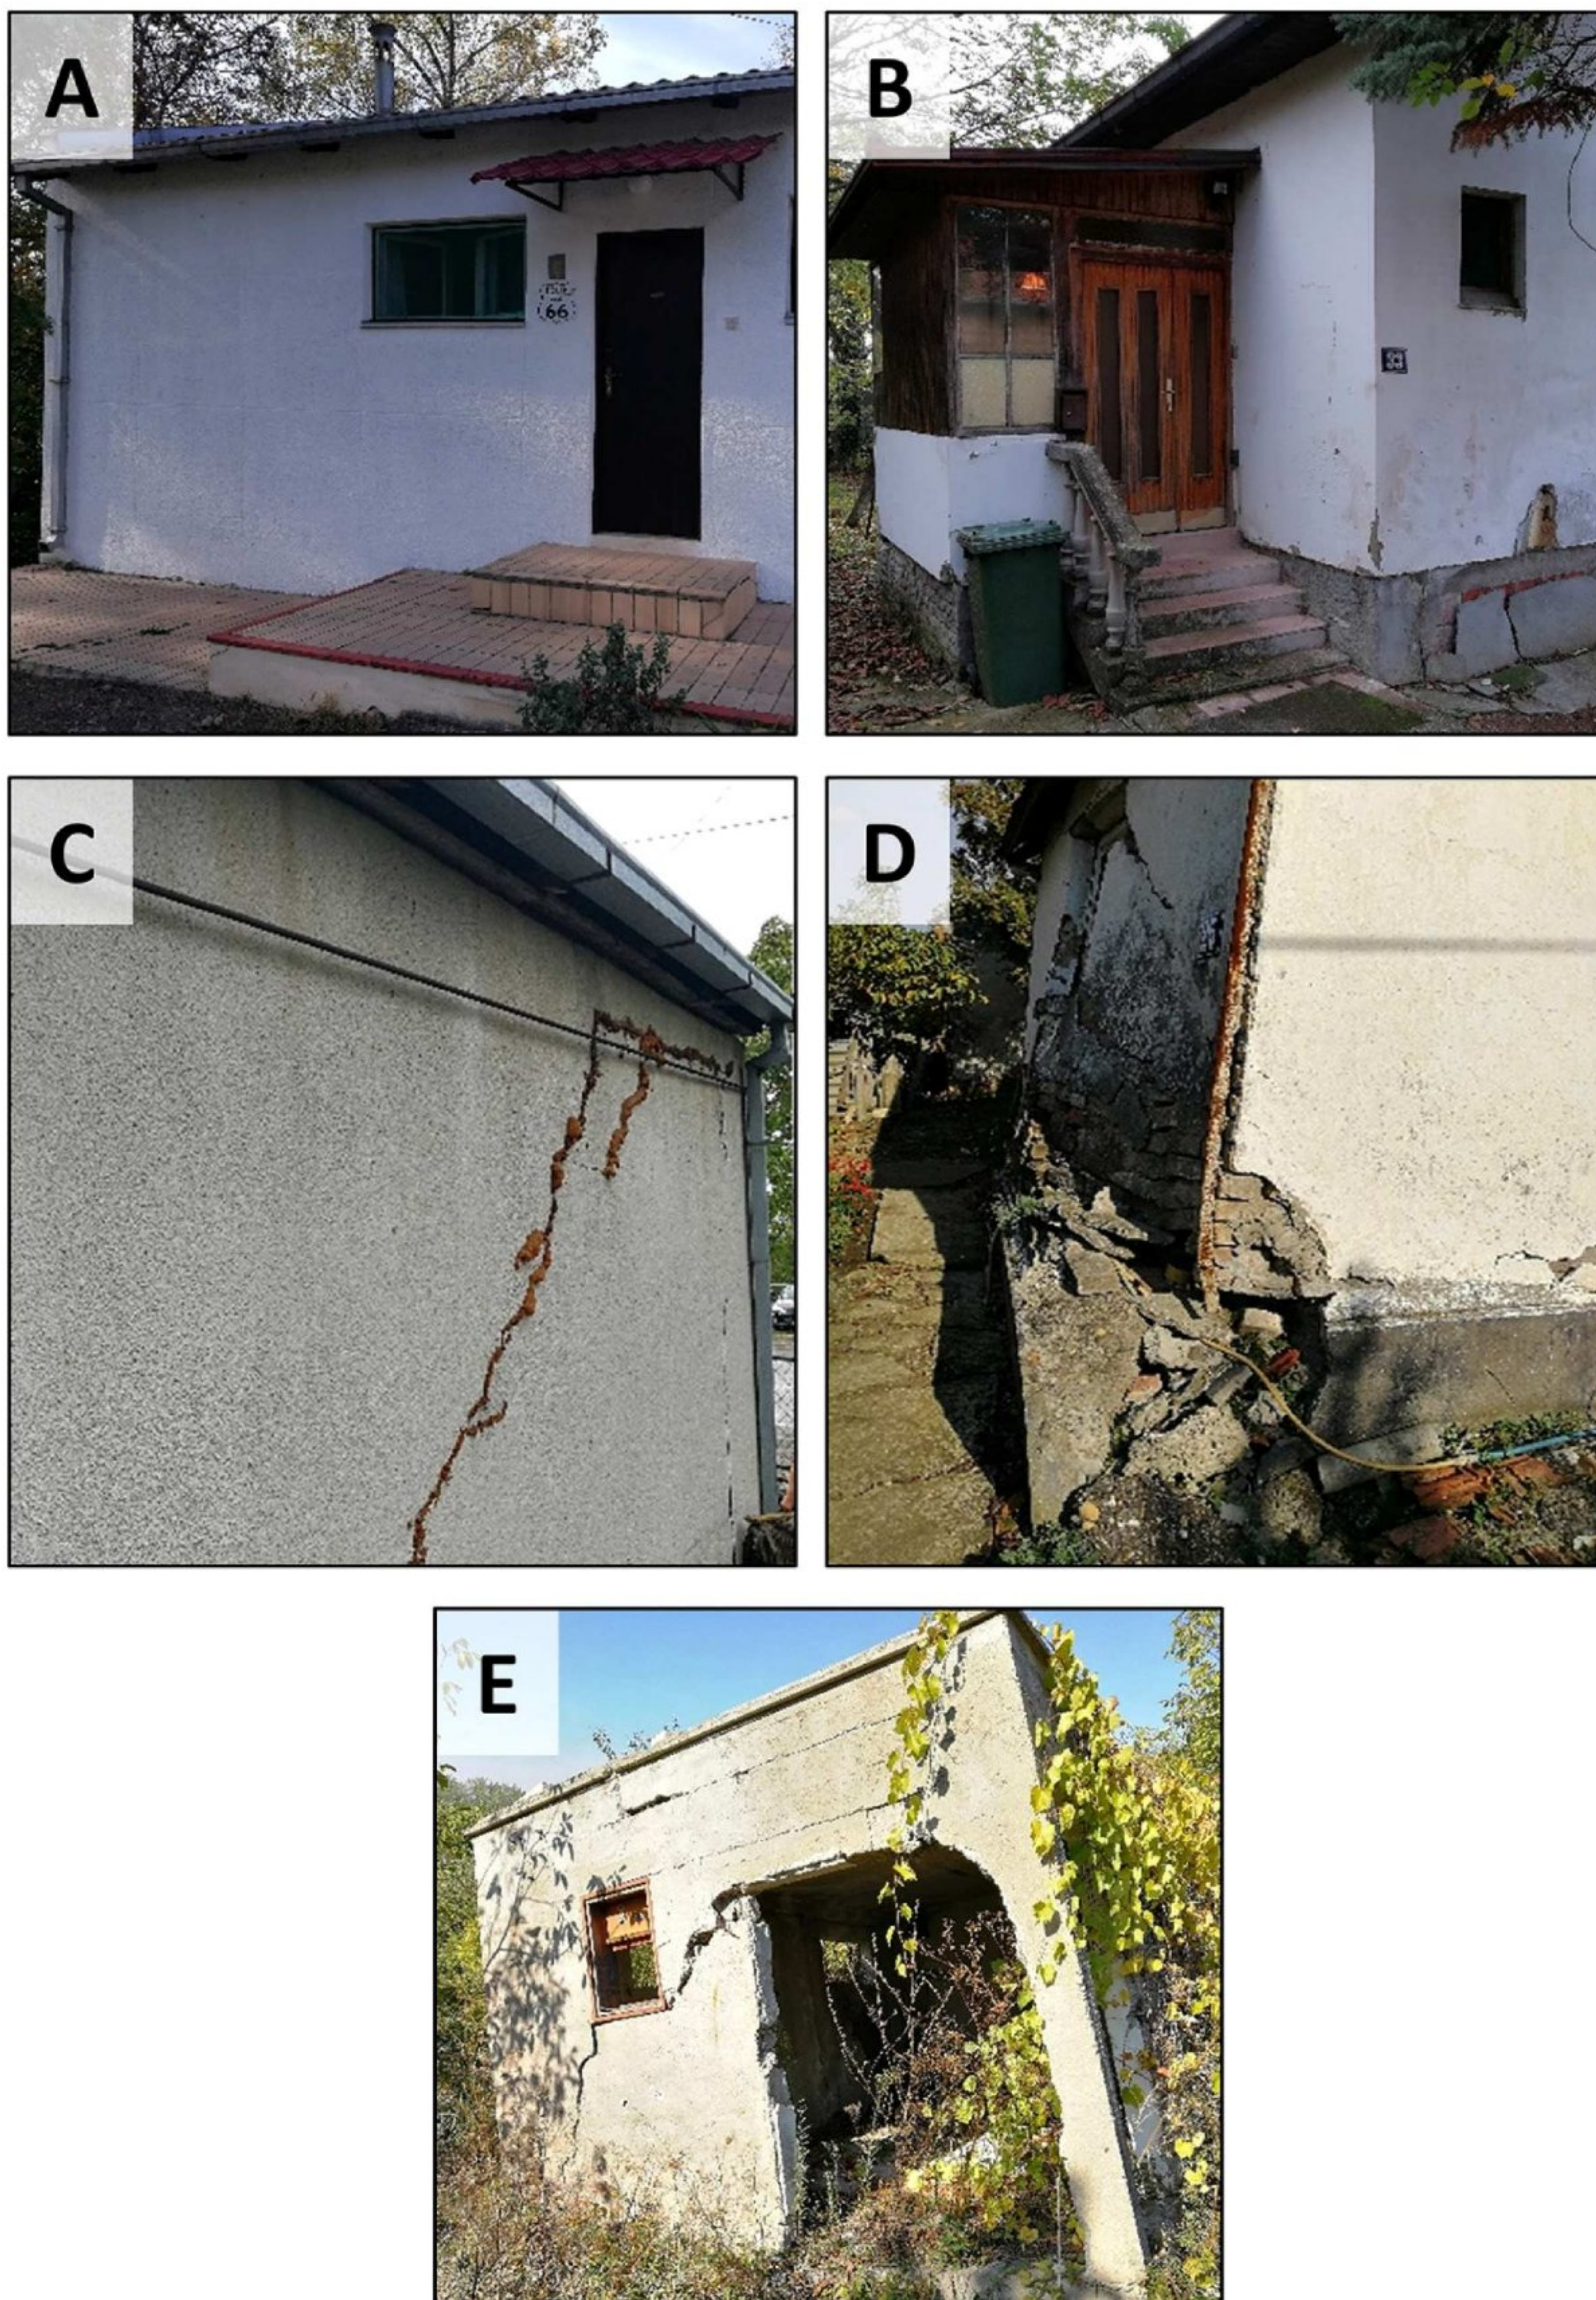
**Figure 4.** Photographs of selected buildings on the ‘Umka’ landslide by damage category based on the criteria outlined in Table 1: **(A)** Building without damage; **(B)** Slightly damaged building; **(C)** Damaged building; **(D)** Heavily damaged building; **(E)** Destroyed/ Collapsed building.

Results of the building survey showed that only 69 (18%) buildings were without any deformation and 90 (24%) buildings had slight damage from the landslide. 100 (27%) buildings were classified as damaged and 74 (20%) as heavily damaged while 42 buildings were identified as damaged or destroyed.

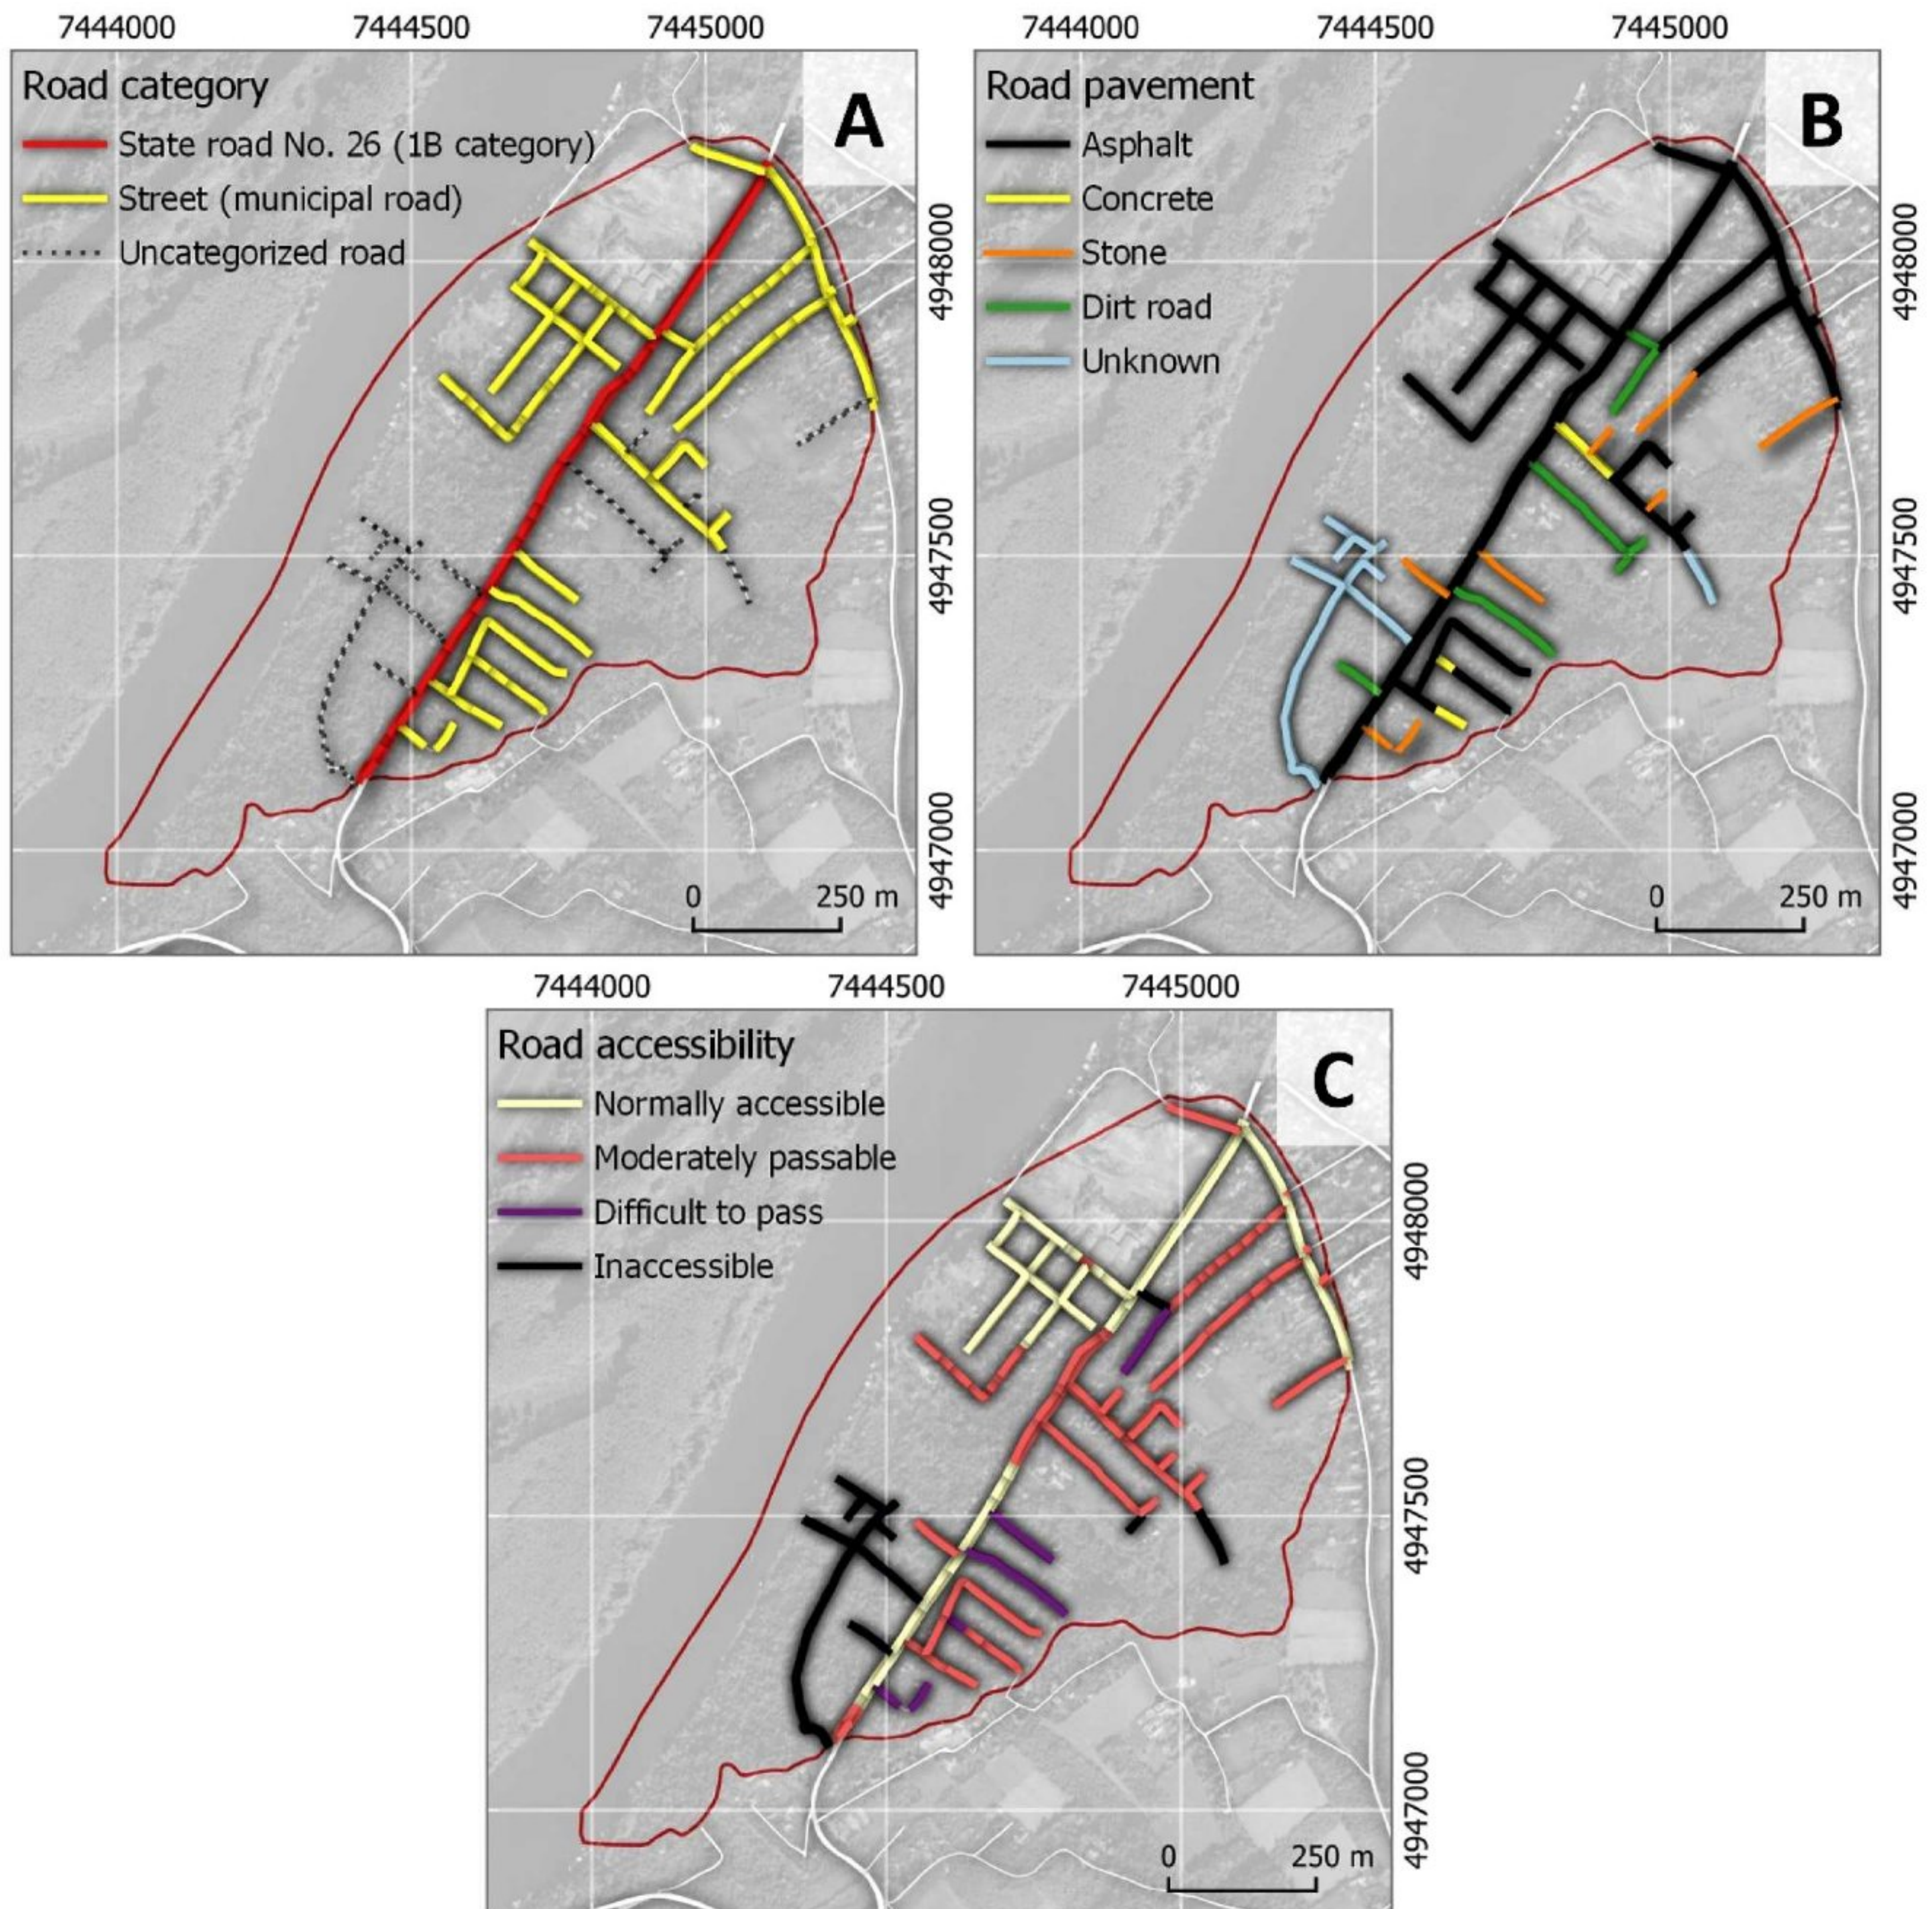
**Figure 5.** (A) Road category map of the 'Umka' landslide; (B) Road pavement map of the 'Umka' landslide; (C) Road accessibility map of the 'Umka' landslide.

The landslide 'Umka' crosses a total of 7.1 km of roads of various categories, as shown in Figure 5A. The most prevalent type of road within the landslide area is streets (municipal roads), which account for 4.15 km

Based on the material of the pavement within the ‘Umka’ landslide, the road surface is mostly comprised of asphalt (Figure 5B) with a total length of 4.4 km (61%). Dirt roads account for 0.8 km (11%), followed by stone pavement, which has a total length of 0.7 km (9.9%). Concrete is the least represented, accounting for 0.2 km (3.1%). It was not possible to determine the type of material for the 1 km (15%) of roads that have been destroyed (classified as Unknown).

In terms of accessibility, 2.2 km (31%) of the roads are considered normally accessible, 3 km (44%) are moderately passable, 0.6 km (8%) are difficult to pass, and 1.2 km (17%) are inaccessible. The map of traffic roads is illustrated in (Figure 5C).

The analysis further showed that only 38% of the roads are undamaged or have minor damage, while 62% are damaged, significantly or completely, preventing their regular use. The biggest risk is the deformation of the state road N°26, which significantly slows down the traffic and affects its safety, thus preventing safe access and regular use of the street infrastructure for most of the residents.
