Review of the Failure at the Flotation Tailings Storage Facility of the “Stolice” Mine (Serbia)

Dragana Nišić, Nikoleta Aleksić, Bojan Živanović, Uroš Pantelić, Veljko Rupar

10.3390/app142210163

Review

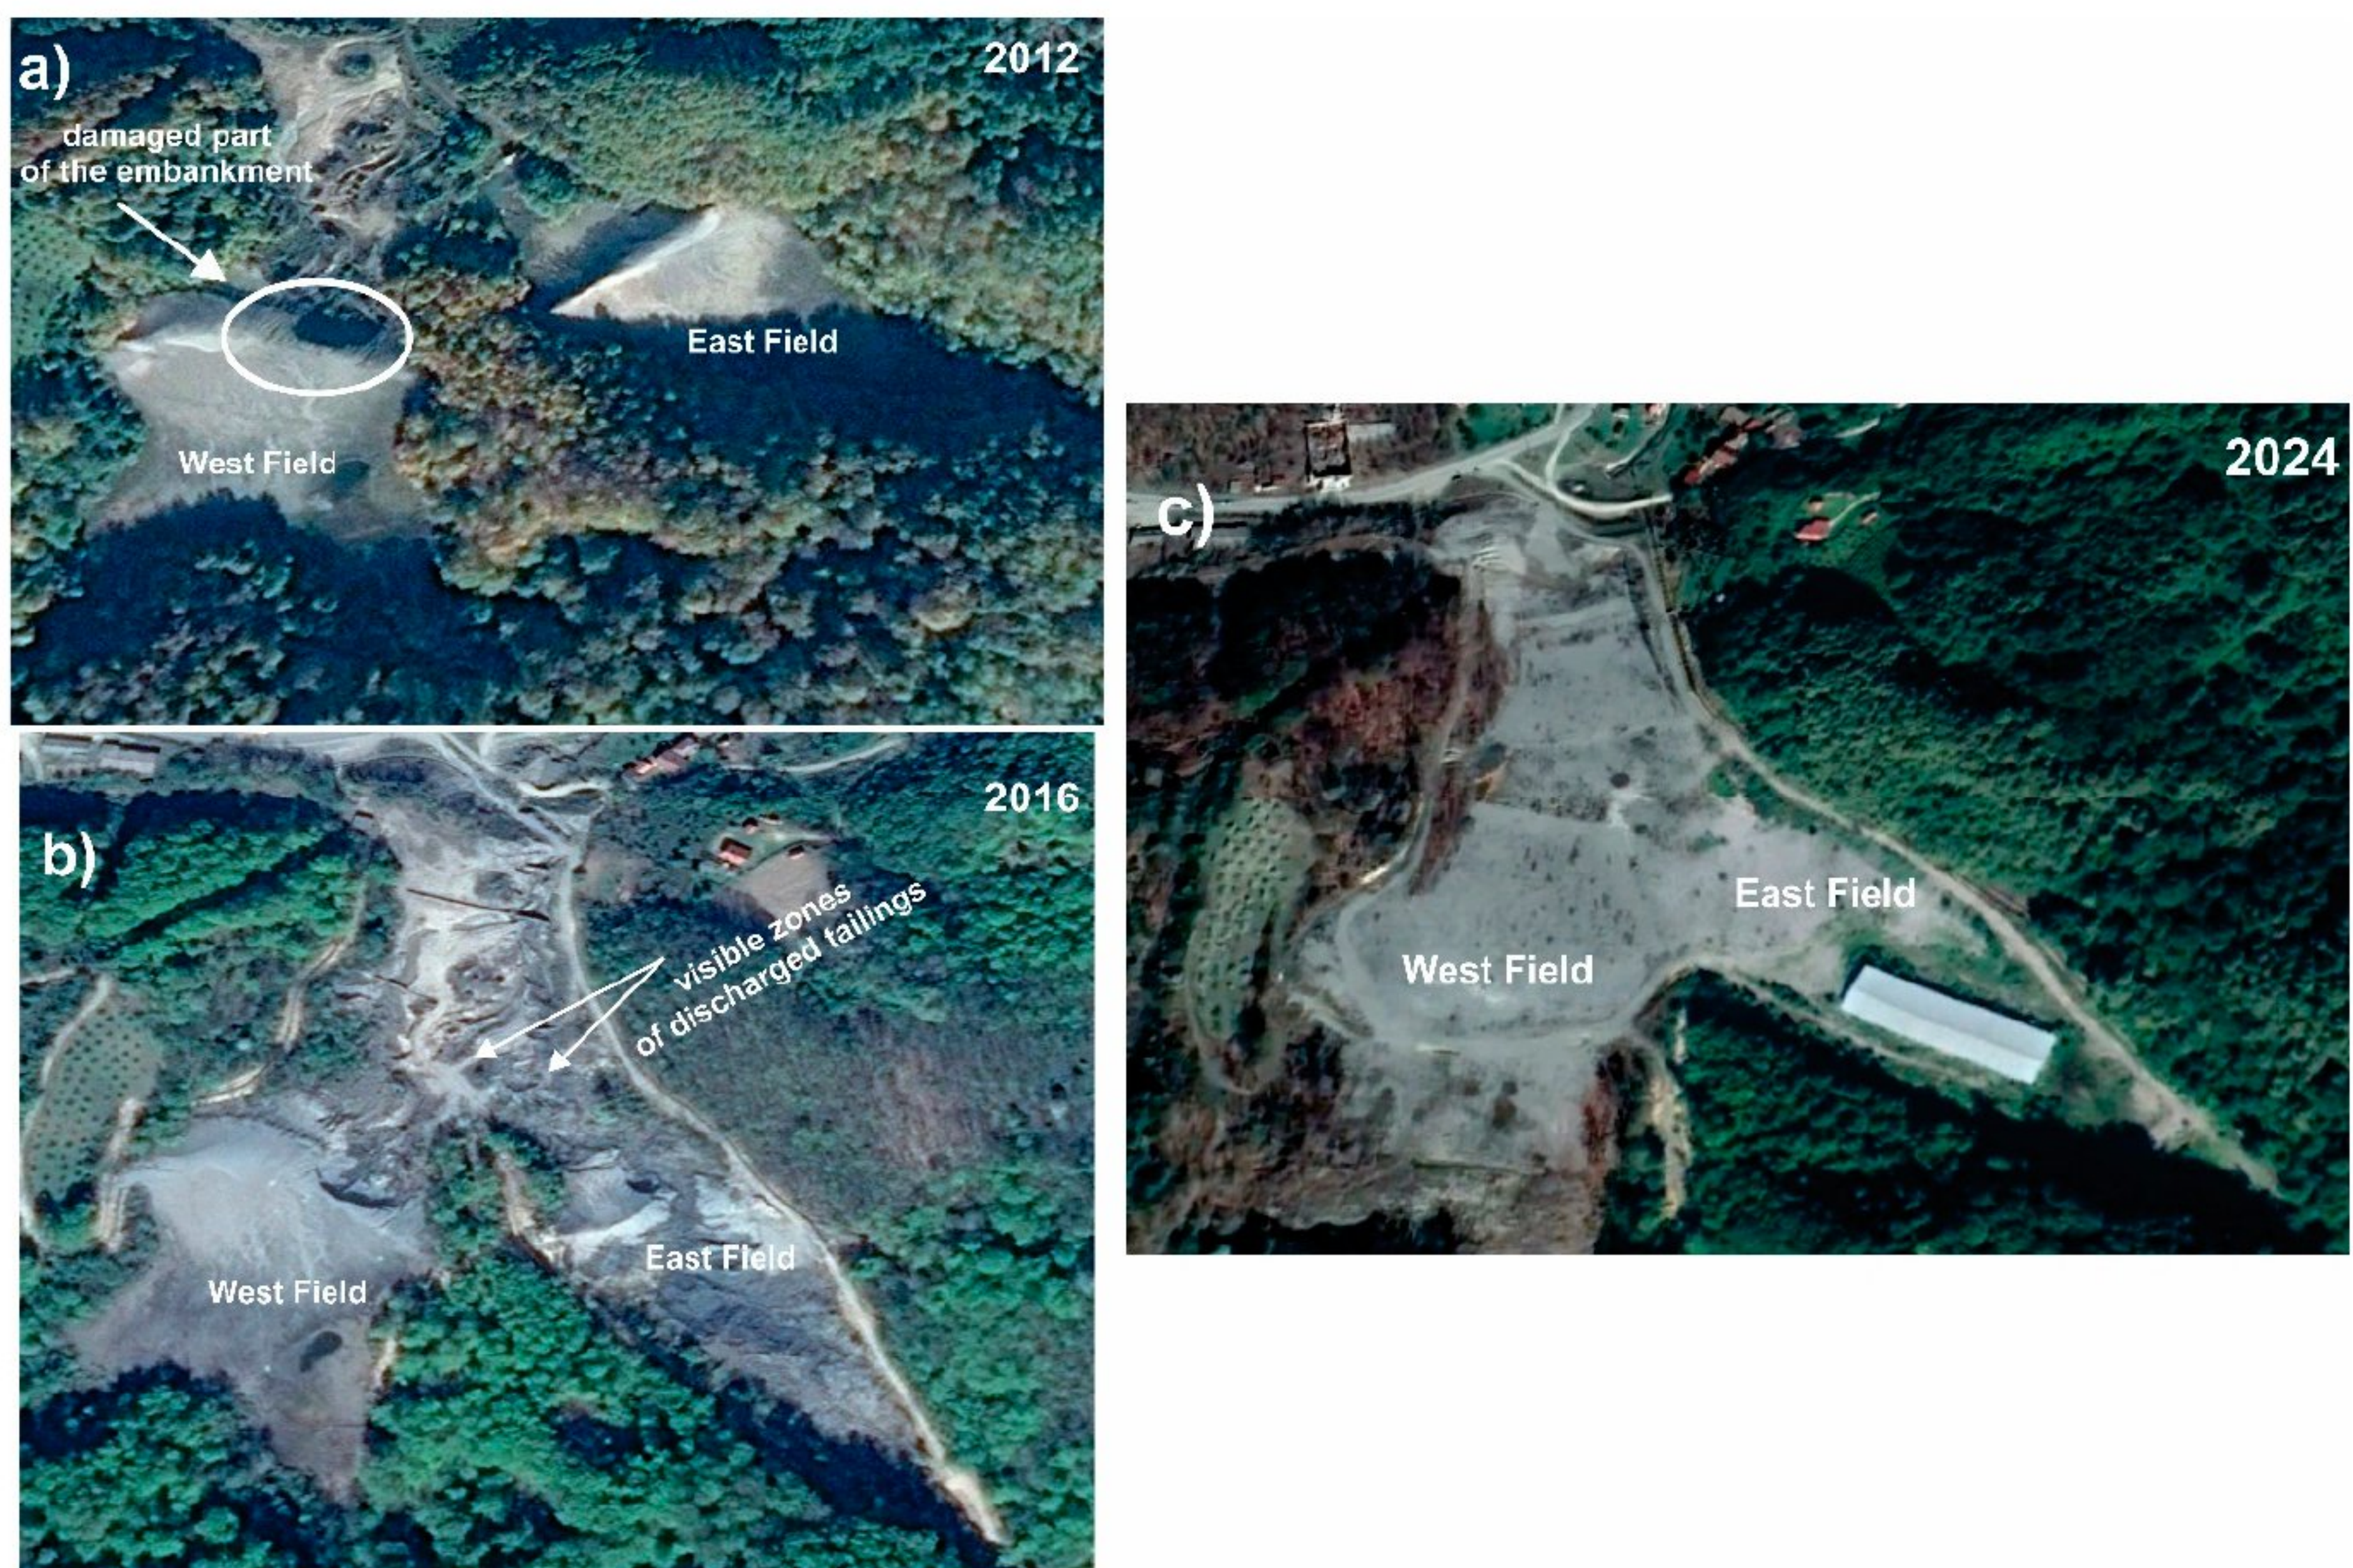
The flotation TSF of the “Stolice” mine has not been active since 1990. According to the image of the TSF from 2012 (Figure 3a), it is clear that the embankment on the west field of the TSF was already damaged. Regardless of this fact, no accidents had been recorded at this TSF before. During May of 2014, the so-called “Tamara” cyclone caused heavy rainfall and caused what are considered to be the largest floods ever recorded in certain parts of Central and West Serbia [15]. The region of the TSF of the mine “Stolice” had 200–250 mm of rainfall in only 3 days, surpassing the so-called 100-year flood [16].

Figure 3. The flotation TSF of the mine “Stolice”: (a) image from 2012, before the accident; (b) image from 2016, after the accident and before rehabilitation; (c) image from 2024, after rehabilitation [17].

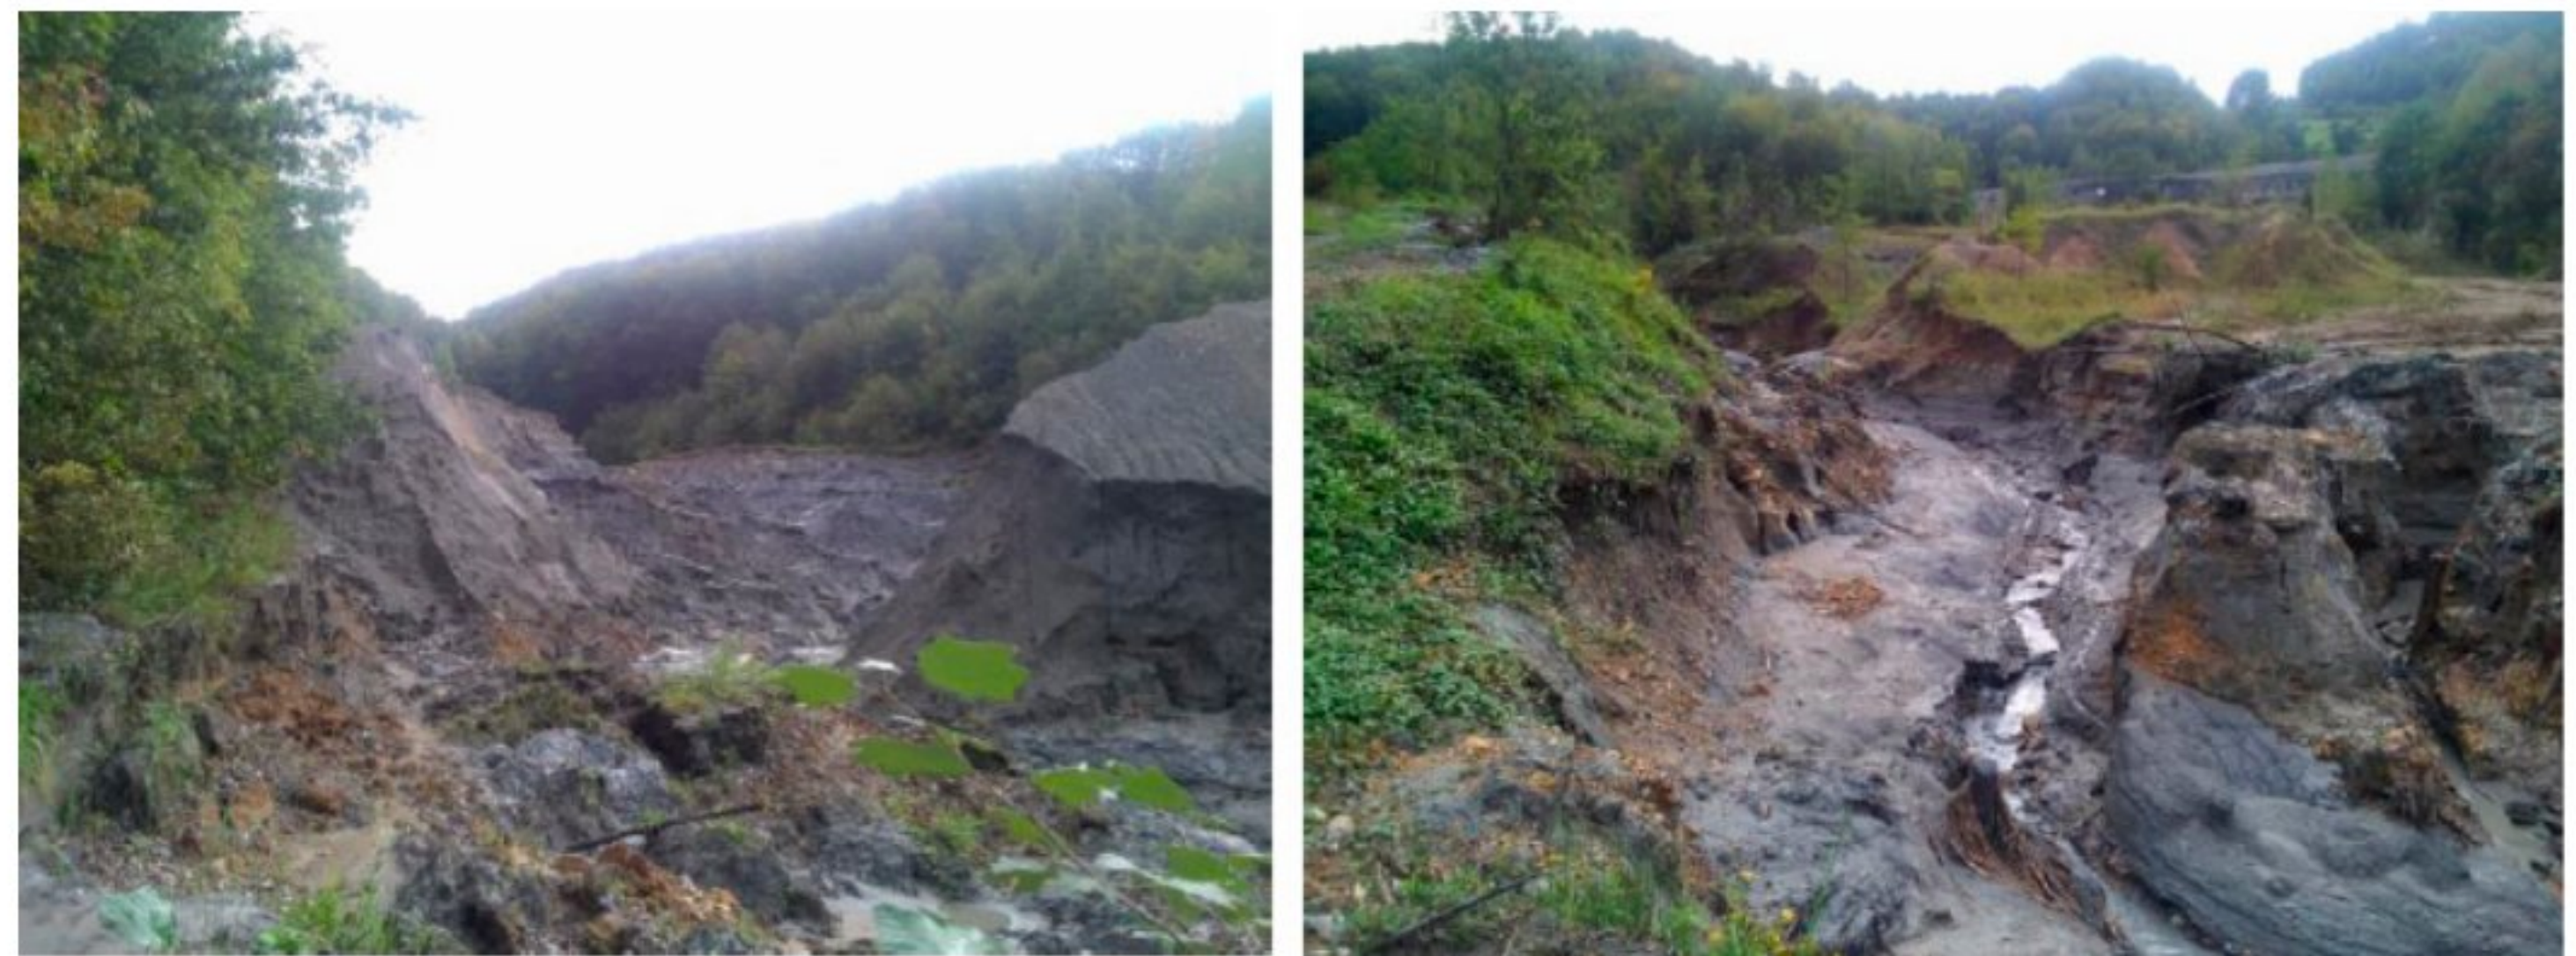
On 13 May 2014, due to the inflow of a large amount of precipitation and the saturation of tailings with water, there was a filtration disturbance in the eastern field embankment, and as the drainage worked poorly, it caused a break in the embankment and there was an overflow of the deposited tailings from the eastern field (Figure 4). On that occasion, a flood wave was formed, and the spilled tailings reached the Kostajnička River, where they were further transported to the Korenita River. Considering that there was intense rainfall for days (from 13 to 16 May), the spilling of eastern field tailings was recorded for days. Until that moment, the western field was stable, without visible water on the surface.

Figure 4. The damaged embankment of the eastern field. Reproduced with permission from the Water Institute “Jaroslav Černí” [10].

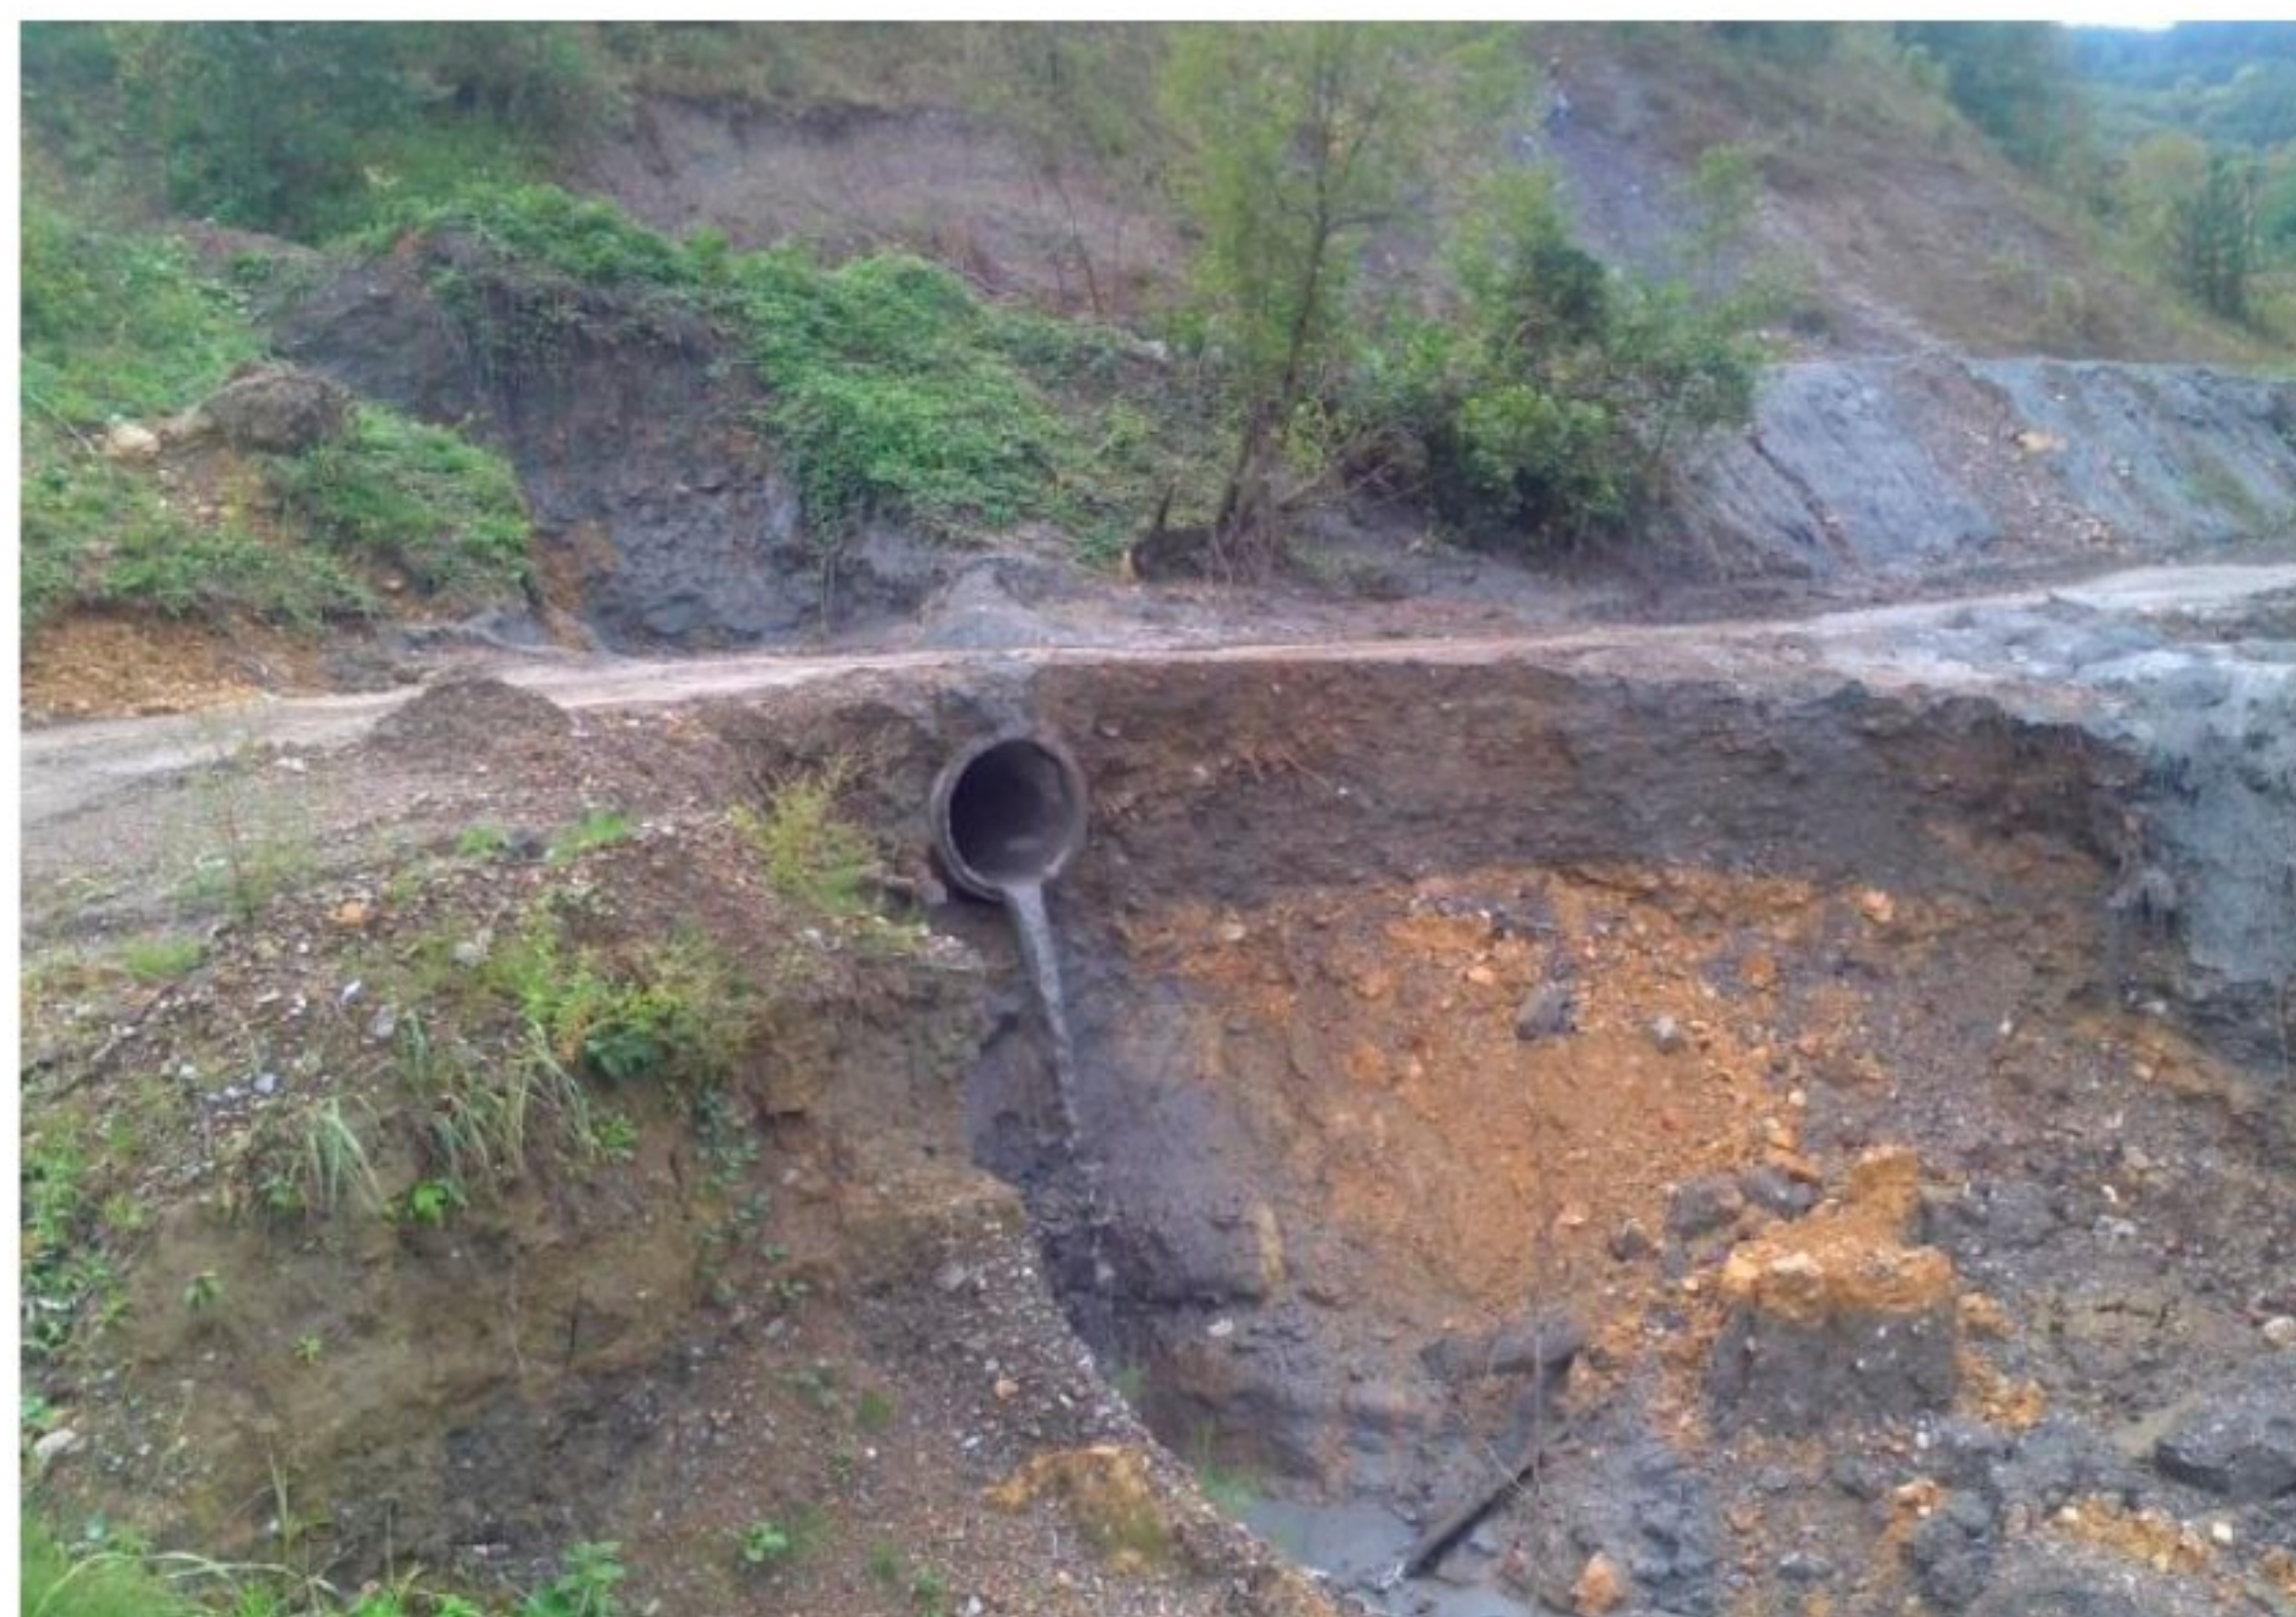
Just two days later, on 15 May 2014, continuous rainfall triggered a natural landslide above the western field. The landslide was particularly concerning because it added a large amount of debris into the western field, which was already at risk due to the heavy precipitation. The additional weight from the landslide further stressed the embankment, weakening its integrity. On that occasion, the pipe culvert regulating the Bezimeni Stream on the western flank of the TSF was damaged (Figure 5).

Figure 5. The damaged pipe culvert on the western field. Reproduced with permission from the Water Institute “Jaroslav Černí” [10].

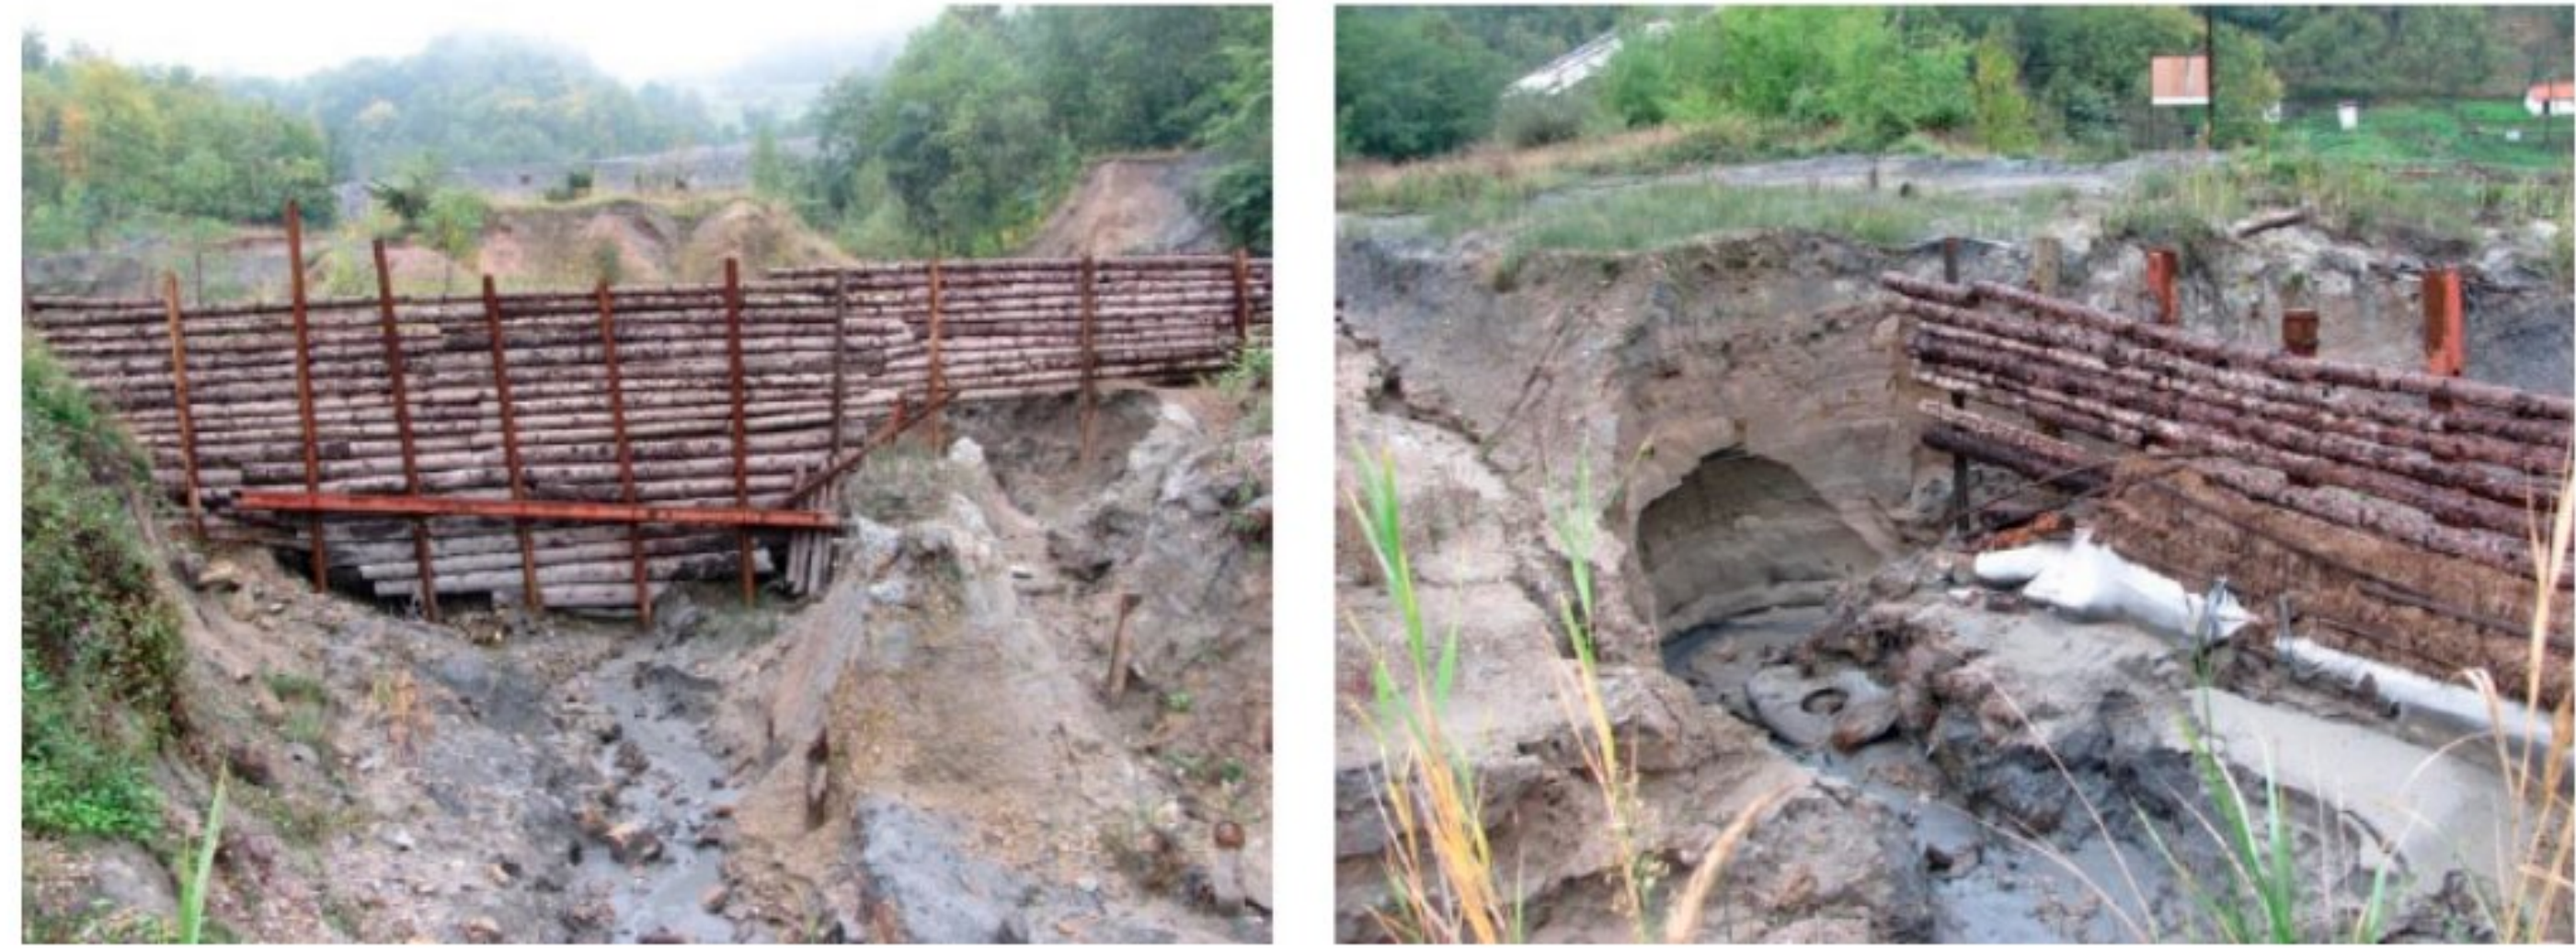
On 23 May 2014, the Bezimeni stream began to fill the western field with water, which finally caused the western field embankment to breach [5]. An even larger volume of tailings into the surrounding environment was released than in previous phases. The release of tailings lasted for days after those temporary measures for the reconstruction of the TSF were introduced. The improvised wooden embankment was installed (Figure 6).

Figure 6. The improvised wooden embankment of the eastern field. Reproduced with permission from the Water Institute “Jaroslav Černi” [10].

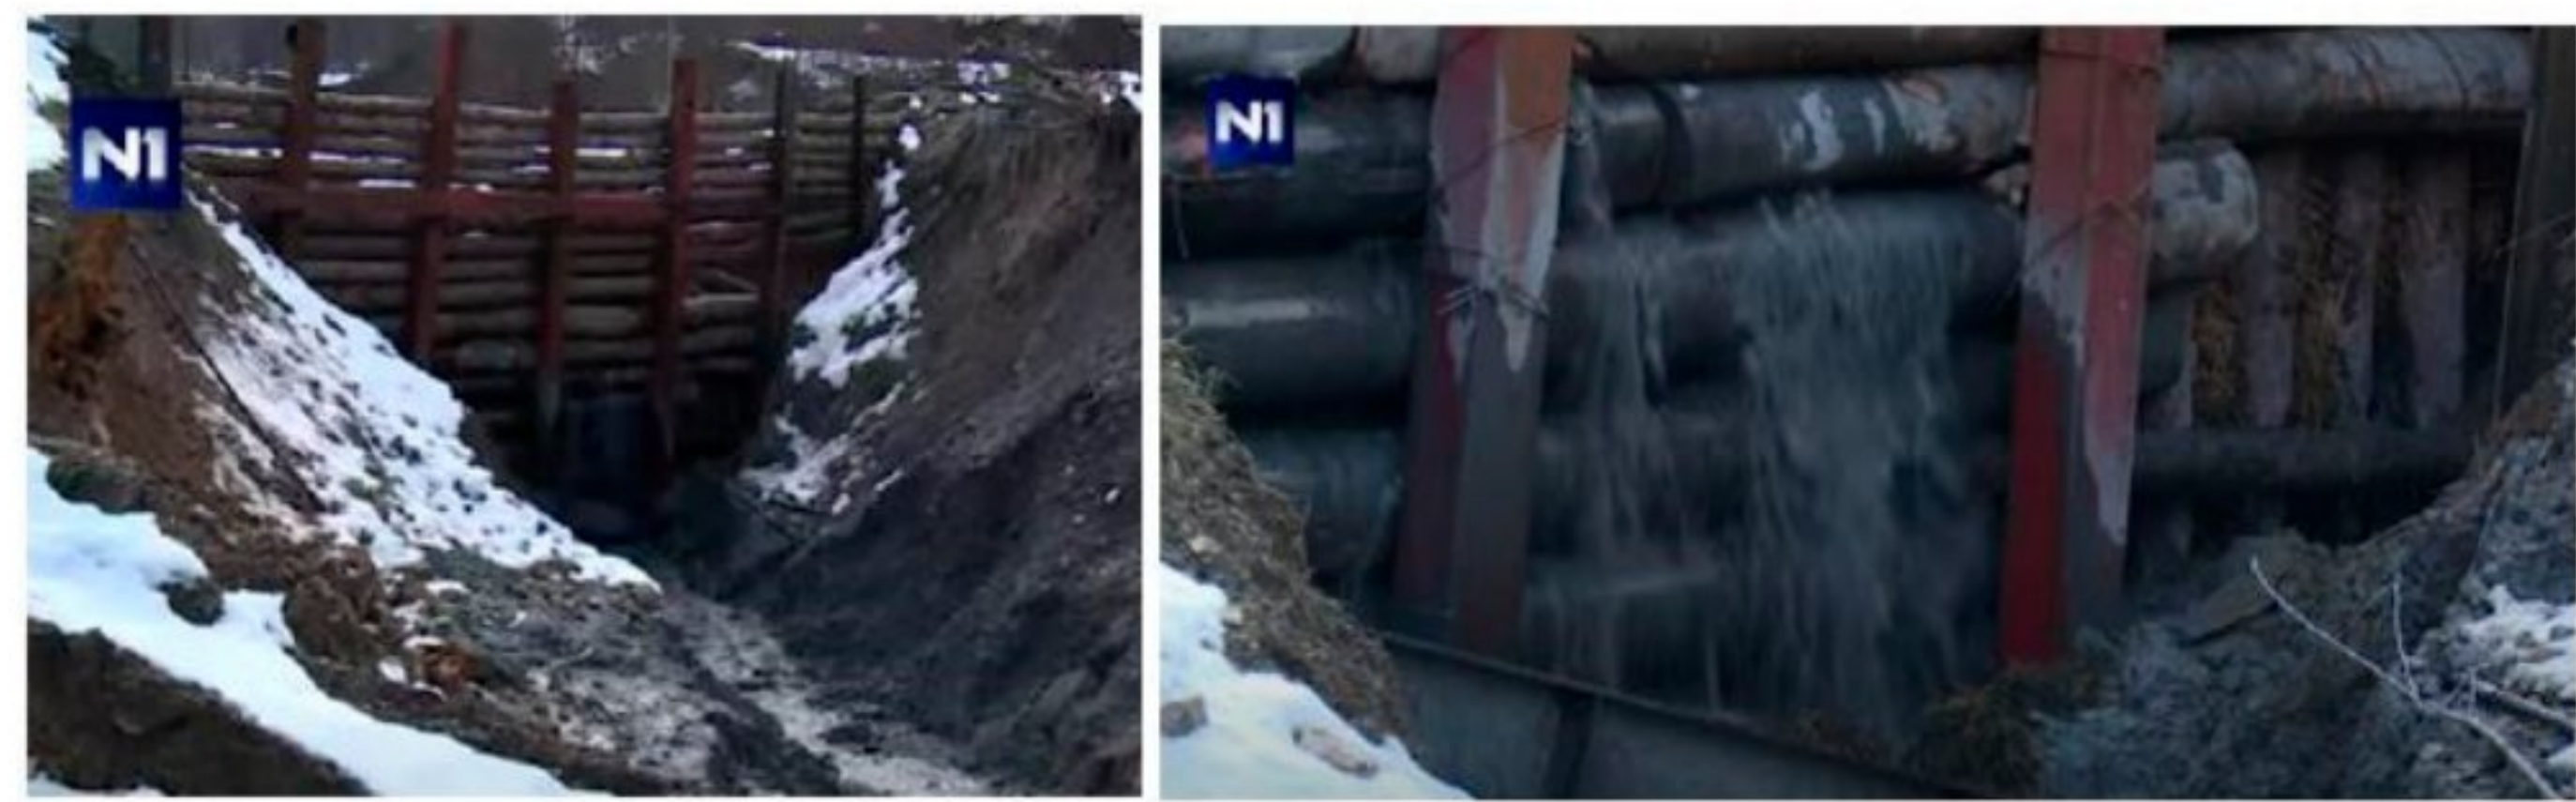
On 17 July of the same year, the tailings spilled again when the already-damaged eastern field embankment, which was temporarily blocked off by the wooden embankment at that moment, was breached and additional tailings spilled into the Kostajnička River (Figure 7) [18]. The repeated failure highlighted the need for more robust remediation efforts and long-term solutions to prevent future accidents of this nature.

Figure 7. The temporarily blocked eastern tailings field was breached again on 17 July 2014. Reproduced with permission from N1 Television [19].

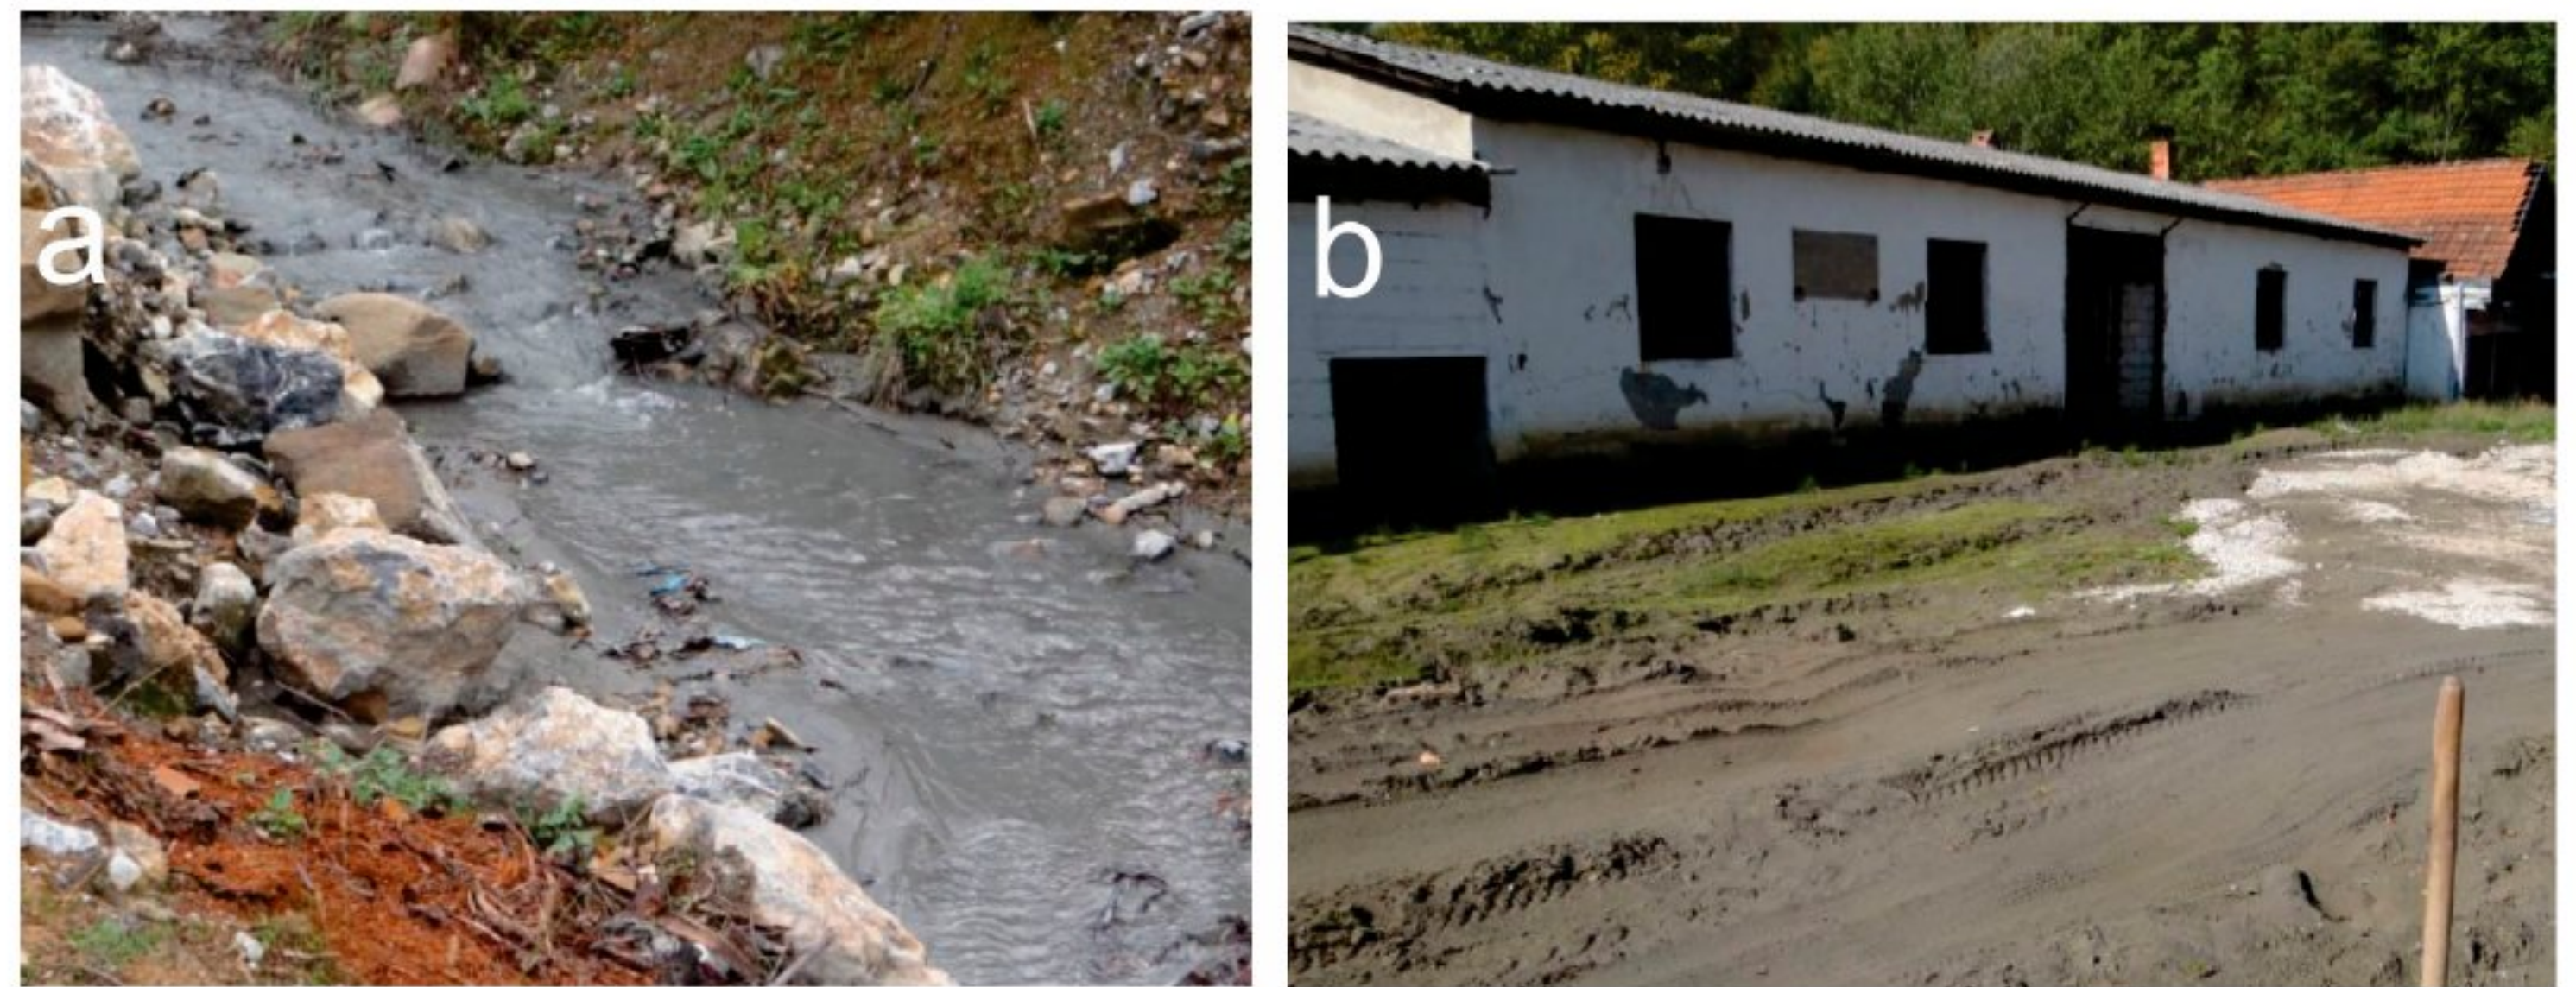
During the accident, a total of between 70,000 and 100,000 m³ of the deposited tailings spilled from the TSF, with most of the tailings spilling from the eastern field [20]. The beds of the Kostajnička River and the Korenita River were devastated, especially the unregulated parts of the riverbeds. The spilled tailings were deposited on the banks of the Kostajnička River, spanning 5 km, and the Korenita River, spanning 20 km, up to the confluence with the Jadar River [11]. Downstream from the TSF, deposits of spilled tailings were created, which were 5–10 cm thick and 50–75 m wide (Figure 8a,b) [21]. It has been estimated that the total contaminated surface of the arable and non-arable land was around 400 ha. Road No. 149 was completely closed off, and several residential buildings were completely demolished [10]. There were no human casualties [5].

Figure 8. Tailings deposits in the bed of the Kostajnička River (a) and on the surrounding terrain (b). Reproduced with permission from the Water Institute “Jaroslav Černi” [10].

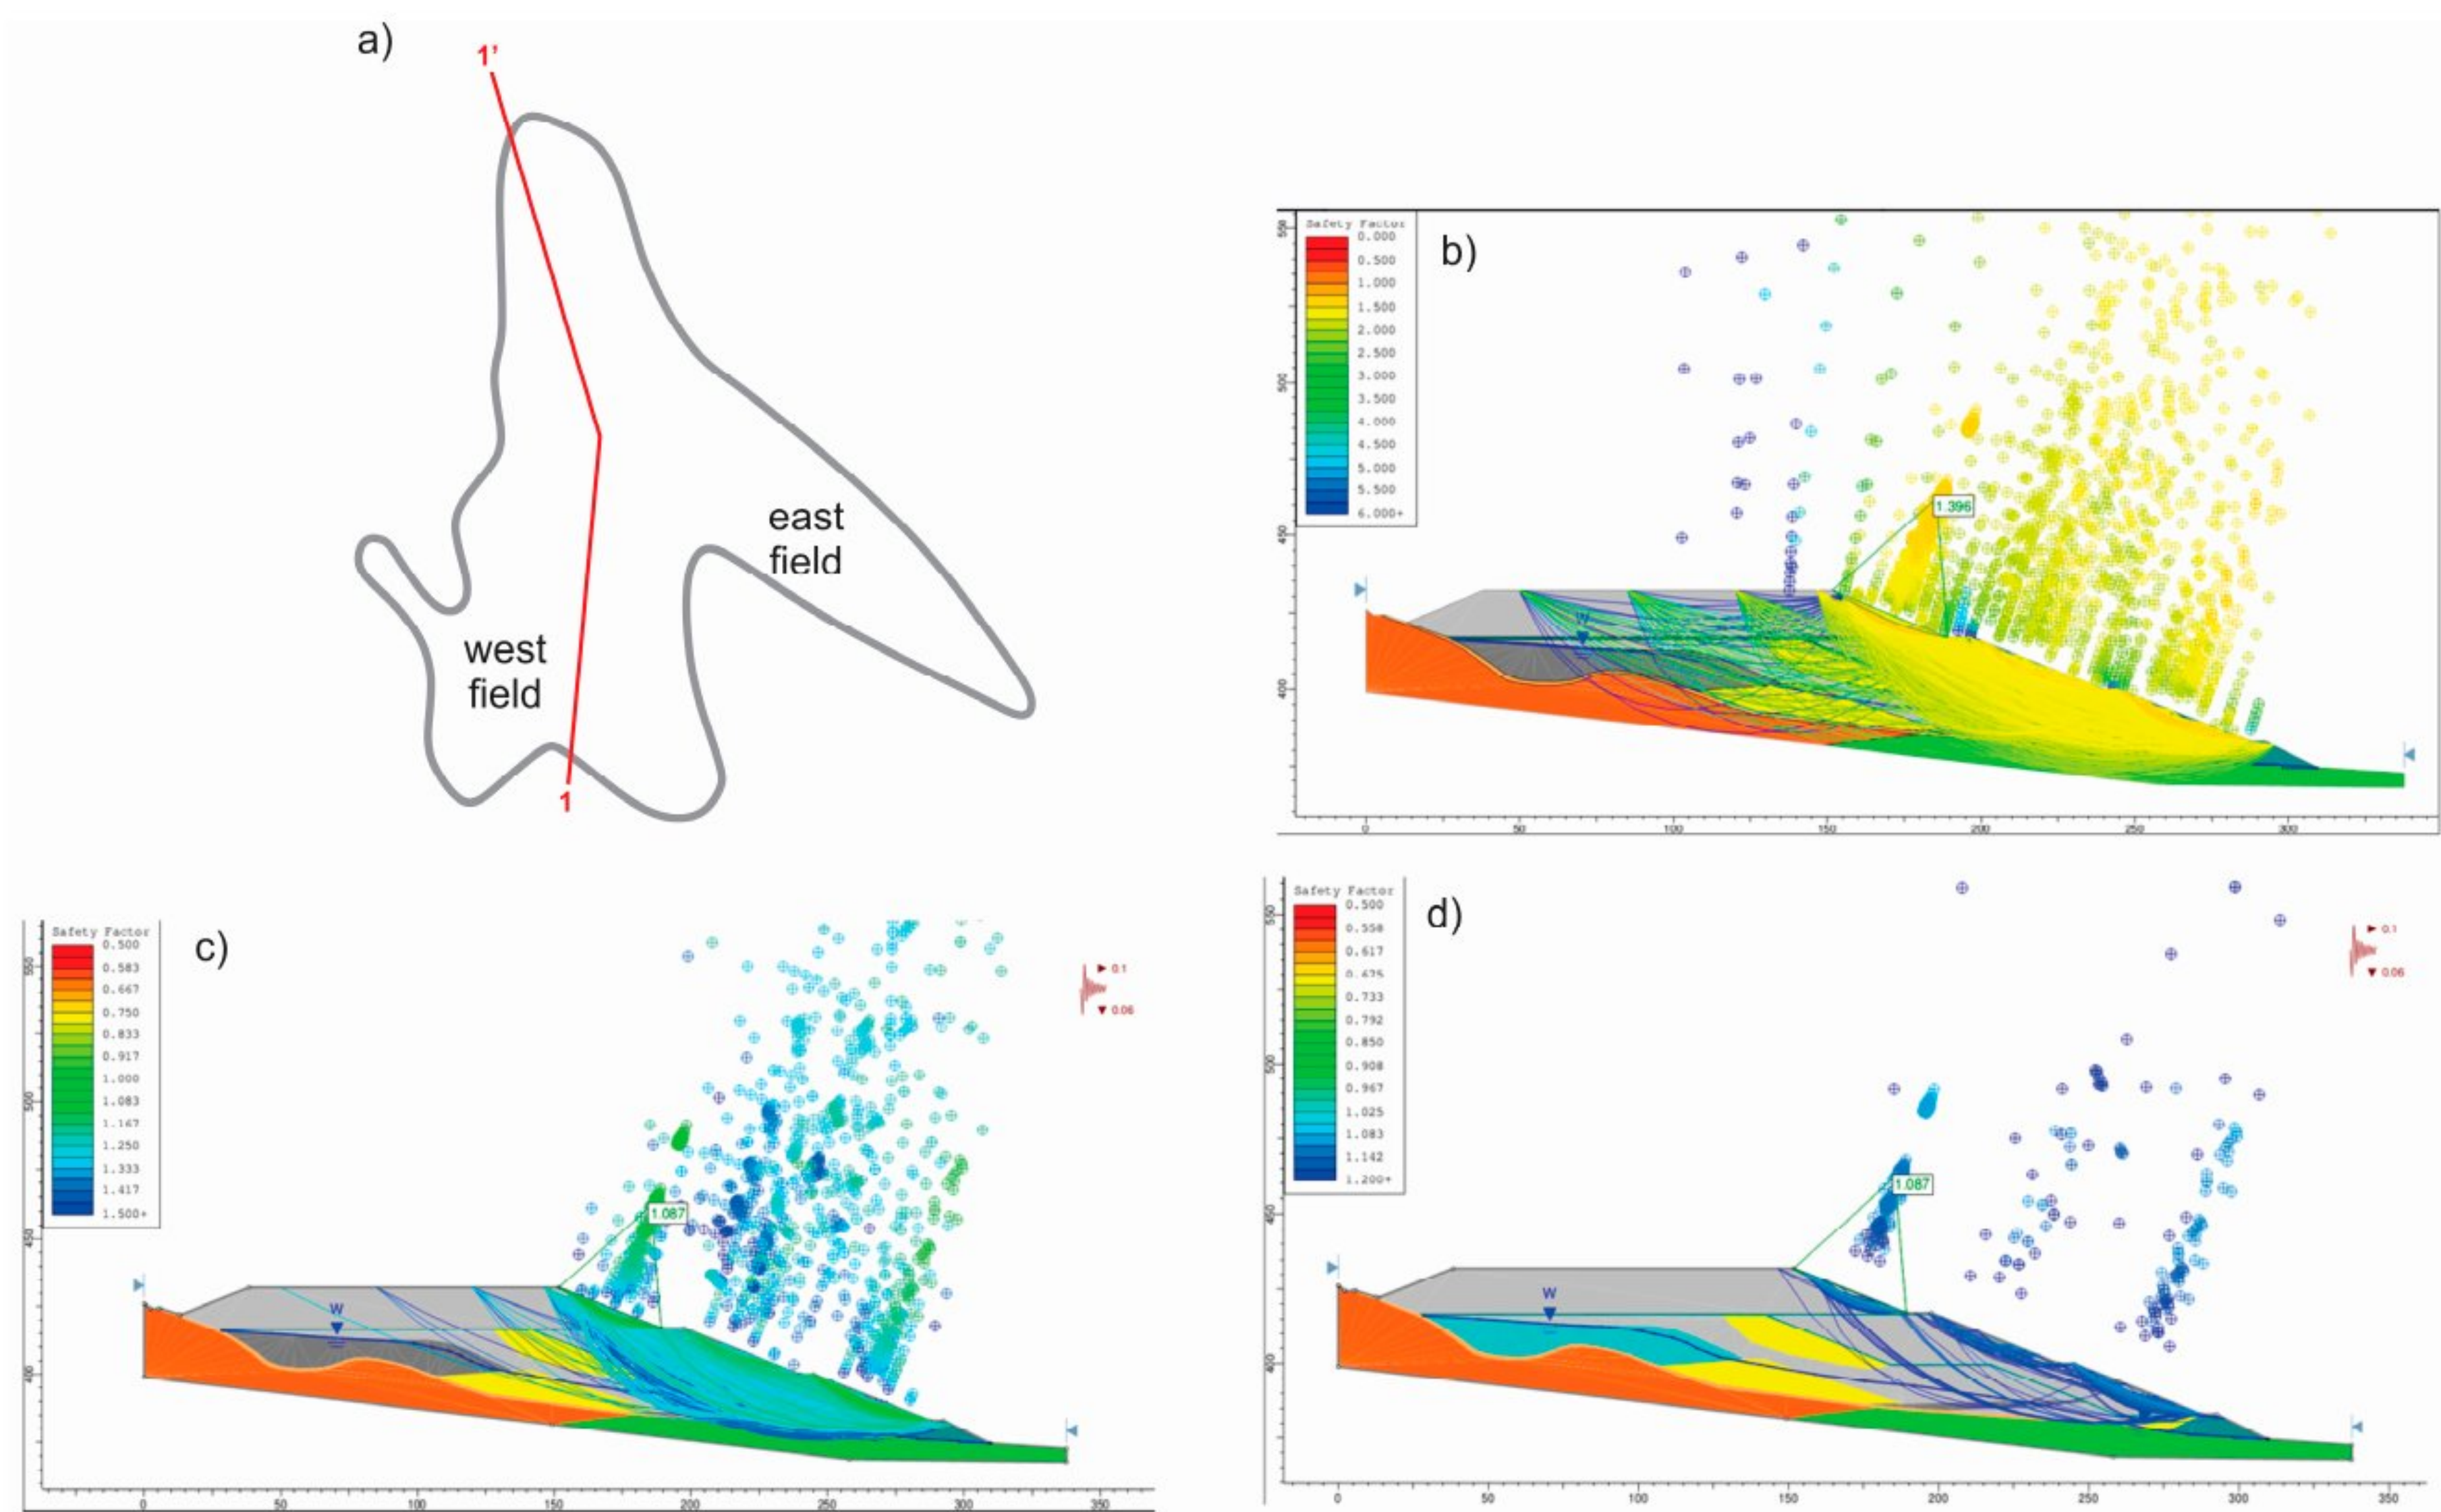
The stability analysis of the reconstructed TSF was conducted for a characteristic longitudinal section, marked as Section 1–1’ in Figure 9a. This section was chosen because in the case of the worst possible scenario, it would give the worst results due to the largest amount of deposited tailings along that section and steep angles of the surrounding terrain [11].

Based on the obtained results of the stability analysis, it can be concluded that the TSF is stable in static and dynamic conditions. These data provide a good basis for risk assessment of another accident at the TSF of the “Stolice” mine. If the 3 × 5 risk assessment matrix is taken into account, the probability of an accident based on the obtained results of the stability analysis can be assessed as “low”. The significance of the consequences is equated with the significance of the already-recorded consequences of accidents from 2014,

Figure 9. Stability analysis of the reconstructed TSF: (a) position of the profile used for analysis; (b) result for static load; (c) result for earthquake load; (d) result for earthquake + liquefaction load. Reproduced with permission from the Water Institute “Jaroslav Černí” [11].

Load Type	Fs [11]	Meaning
Static	1.396 (Figure 9b)	Acceptable Fs. TSF can be considered long-term stable [32].
Earthquake	1.087 (Figure 9c)	Acceptable Fs. TSF can be considered long-term stable [32].
Earthquake + Liquefaction	1.087 (Figure 9d)	Acceptable Fs. TSF can be considered long-term stable [33].
