# Highway construction in fossil landslides zones – Lessons learned from the Grdelica Gorge, Serbia

Biljana Abolmasov, Marinos Skempas, Svetozar Milenković, Janko Radovanović, Miloš Marjanović

Highway construction in fossil landslides zones – Lessons learned from the Grdelica Gorge, Serbia | Biljana Abolmasov, Marinos Skempas, Svetozar Milenković, Janko Radovanović, Miloš Marjanović | 5th Regional symposium on landslides in Adriatic–Balkan Region, 23-26 March 2022 | 2022 | |

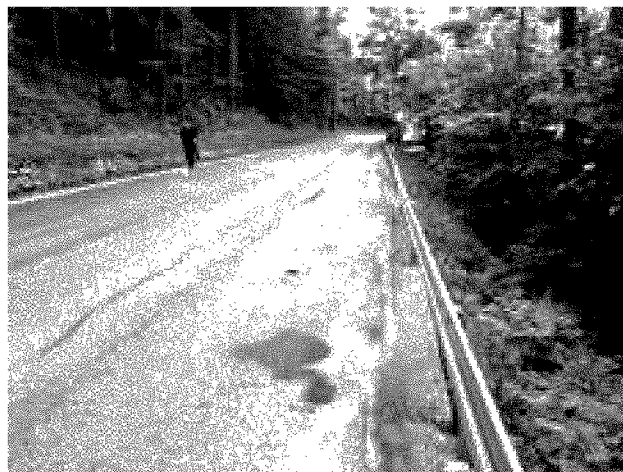
Figure 2 Photo of the state road DC3 (section 015) at km 2+060 before remediation works. Tension cracks at the crown of the landslide Dedin are visible on the asphalt.

The landslide body is formed in the cover material and deluvial/eluvial deposits. The landslide is most likely triggered due to exceeding the strength of the near-surface materials, traffic vibrations (frequent heavy vehicle traffic) and local disturbance of physical and mechanical characteristics of deluvial-eluvial cover due to continuous atmospheric actions (Fig. 2).

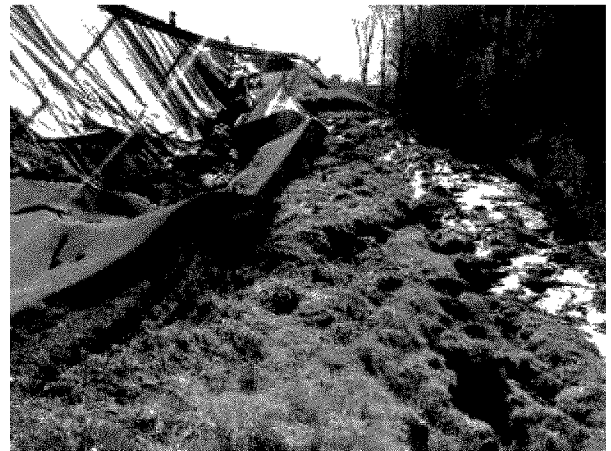
Figure 4 Main scarp of the Dubravci landslide.

The sliding body and accumulation of the material consisted of three cascade like terraces with a height of about 1.5 m between each terrace and was represented by light, water-soaked material which, due to the large mass of running material, causes the fall of trees at the base of the landslide (Fig. 4).

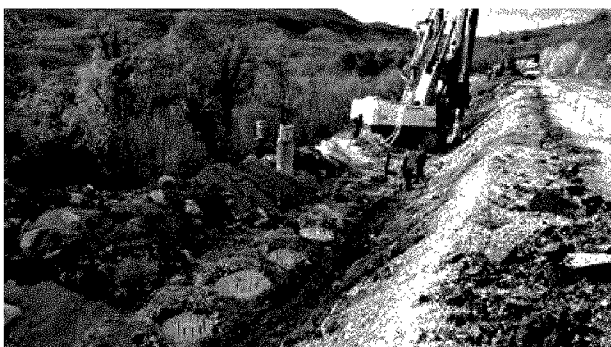
Figure 8 Remediation works on pile wall at Vranja landslide.

The length of the landslide remediation work was 65.0 m, and it consisted of bored piles  $D = 600$  mm in one or two rows (depending on the remediation zone and geological conditions of the site). At the start of work, a temporary barrier was installed (New Jersey bumpers) and temporary traffic control was established. Temporary excavation for the construction of a pile wall and retaining wall was excavated at a slope of  $V:H = 2:1$ .

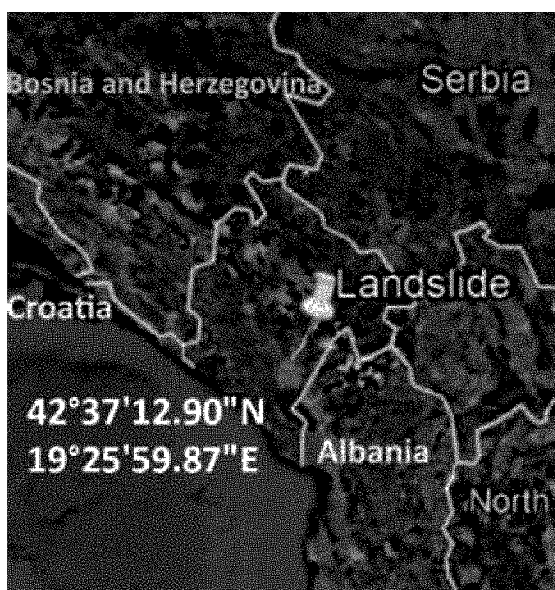
Figure 1 Landslide position.

The landslide is located on the left slope of the open route of the Bar-Boljare highway, Smokovac-Mateševo section, on the chainage from km LK 33+280 to LK 33+420 (Fig. 1). The right lane extends along the bridge Uvač 4.1. The site
