Permanent GNSS monitoring of landslide Umka

Permanent GNSS monitoring of landslide Umka | Mileva Samardžić Petrović, Jovan Popović, Uroš Đurić, Biljana Abolmasov, Marko Pejić, Miloš Marjanović | International Conference on Contemporary Theory and Practice in Construction XIV Stepgrad | 2020 | |

PERMANENT GNSS MONITORING OF LANDSLIDE UMKA

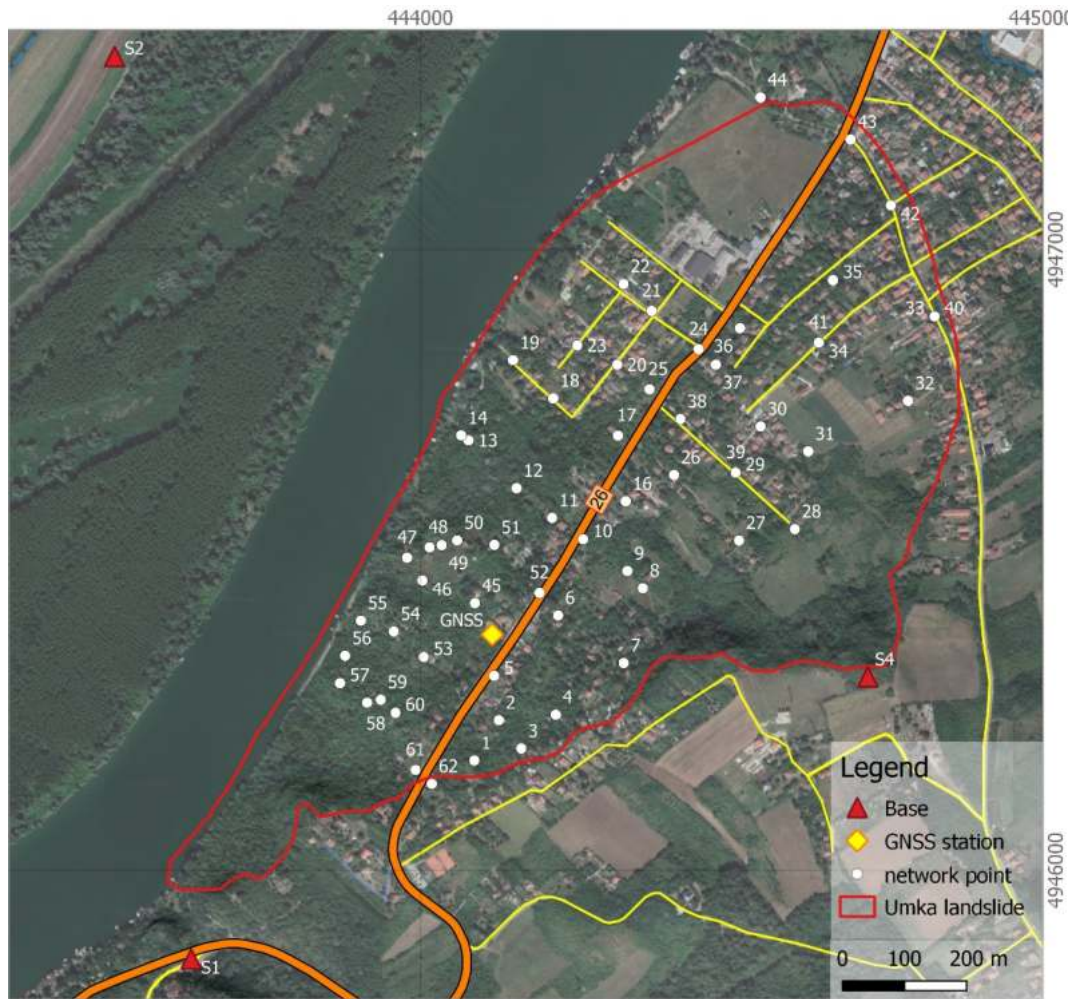
Figure 3. Position of passive GNSS network points and 62 characteristic points of Umka landslide.

As already emphasized, the main shortcoming of the automated GNSS monitoring system used is only one observed object point. Therefore, in order to further analyze the Umka landslide dynamics, a passive GNSS network consisting of four stable points was established at the end of March 2018. Stable points were positioned out of landslide body (Figure 3.). Three stable points (S1, S3 and S4) are located on right bank of the Sava river, and point S2 is located on left bank of the Sava river. Point S1 is stabilized using steel benchmark in asphalt, point S2 is stabilized using massive wooden stake (in loose terrain, embankment), existing stabilization of official state traverse network (P771) was used for point S3, while for point S4 existing trigonometric stone benchmark (I/P16) was used. All stable points were used as a base points for relative kinematic GNSS positioning with post-processing. In addition, the S4 had the additional purpose as a base for real-time kinematic positioning.

In order to monitor the Umka landslide using geodetic methods, 62 points were established on the landslide body (Figure 3). Landslide points are stabilized using steel benchmarks in asphalt, wooden stakes in loose terrain or carved crosses in concrete. Point locations were selected ensuring that the points are homogeneously distributed over the area of activity (as much as the field conditions allow), the points are permanently stabilized without the possibility of easily falling out of bed or moving, and there is a good open sky visibility. Together with the stabilization of 62 landslide points, 20 orientation points for UAV photogrammetric imaging were also stabilized in a convenient arrangement, on locations visible from the air and photo-signalized by colored circles, about 20 cm in diameter.

For seven landslide points (6, 15, 19, 34, 40, 43 and 49) presented on Figure 3. there was no solution in any observation epoch, or they have been destroyed. One point (39) had no solution after the first observation epoch, while the three points (29, 41 and 59) had no solution after the second observation epoch. Based on the results presented on Figure 4, it can be concluded that the majority of obtained displacement azimuths are in the expected zone for the Umka landslide (270° - 360°). As indicated by the results of automated GNSS monitoring system, the landslide body moves toward the Sava river. Due to the large number of characteristic points, only points with horizontal displacements (D) larger than 6 cm, during the time period from April 2018 to April 2019 are presented in Table 2. During the time period from April 2018 to November 2018 the horizontal displacements ranged from 0 cm to 13.9 cm, while the maximum vertical displacement was -23.4 cm. During the time period from April 2018 to April 2019, the horizontal displacements ranged from 0 cm to 19.7 cm, and the maximum vertical displacement was -30.1 cm.
