Review of the Failure at the Flotation Tailings Storage Facility of the “Stolice” Mine (Serbia)

Dragana Nišić, Nikoleta Aleksić, Bojan Živanović, Uroš Pantelić, Veljko Rupar

10.3390/app142210163

Review

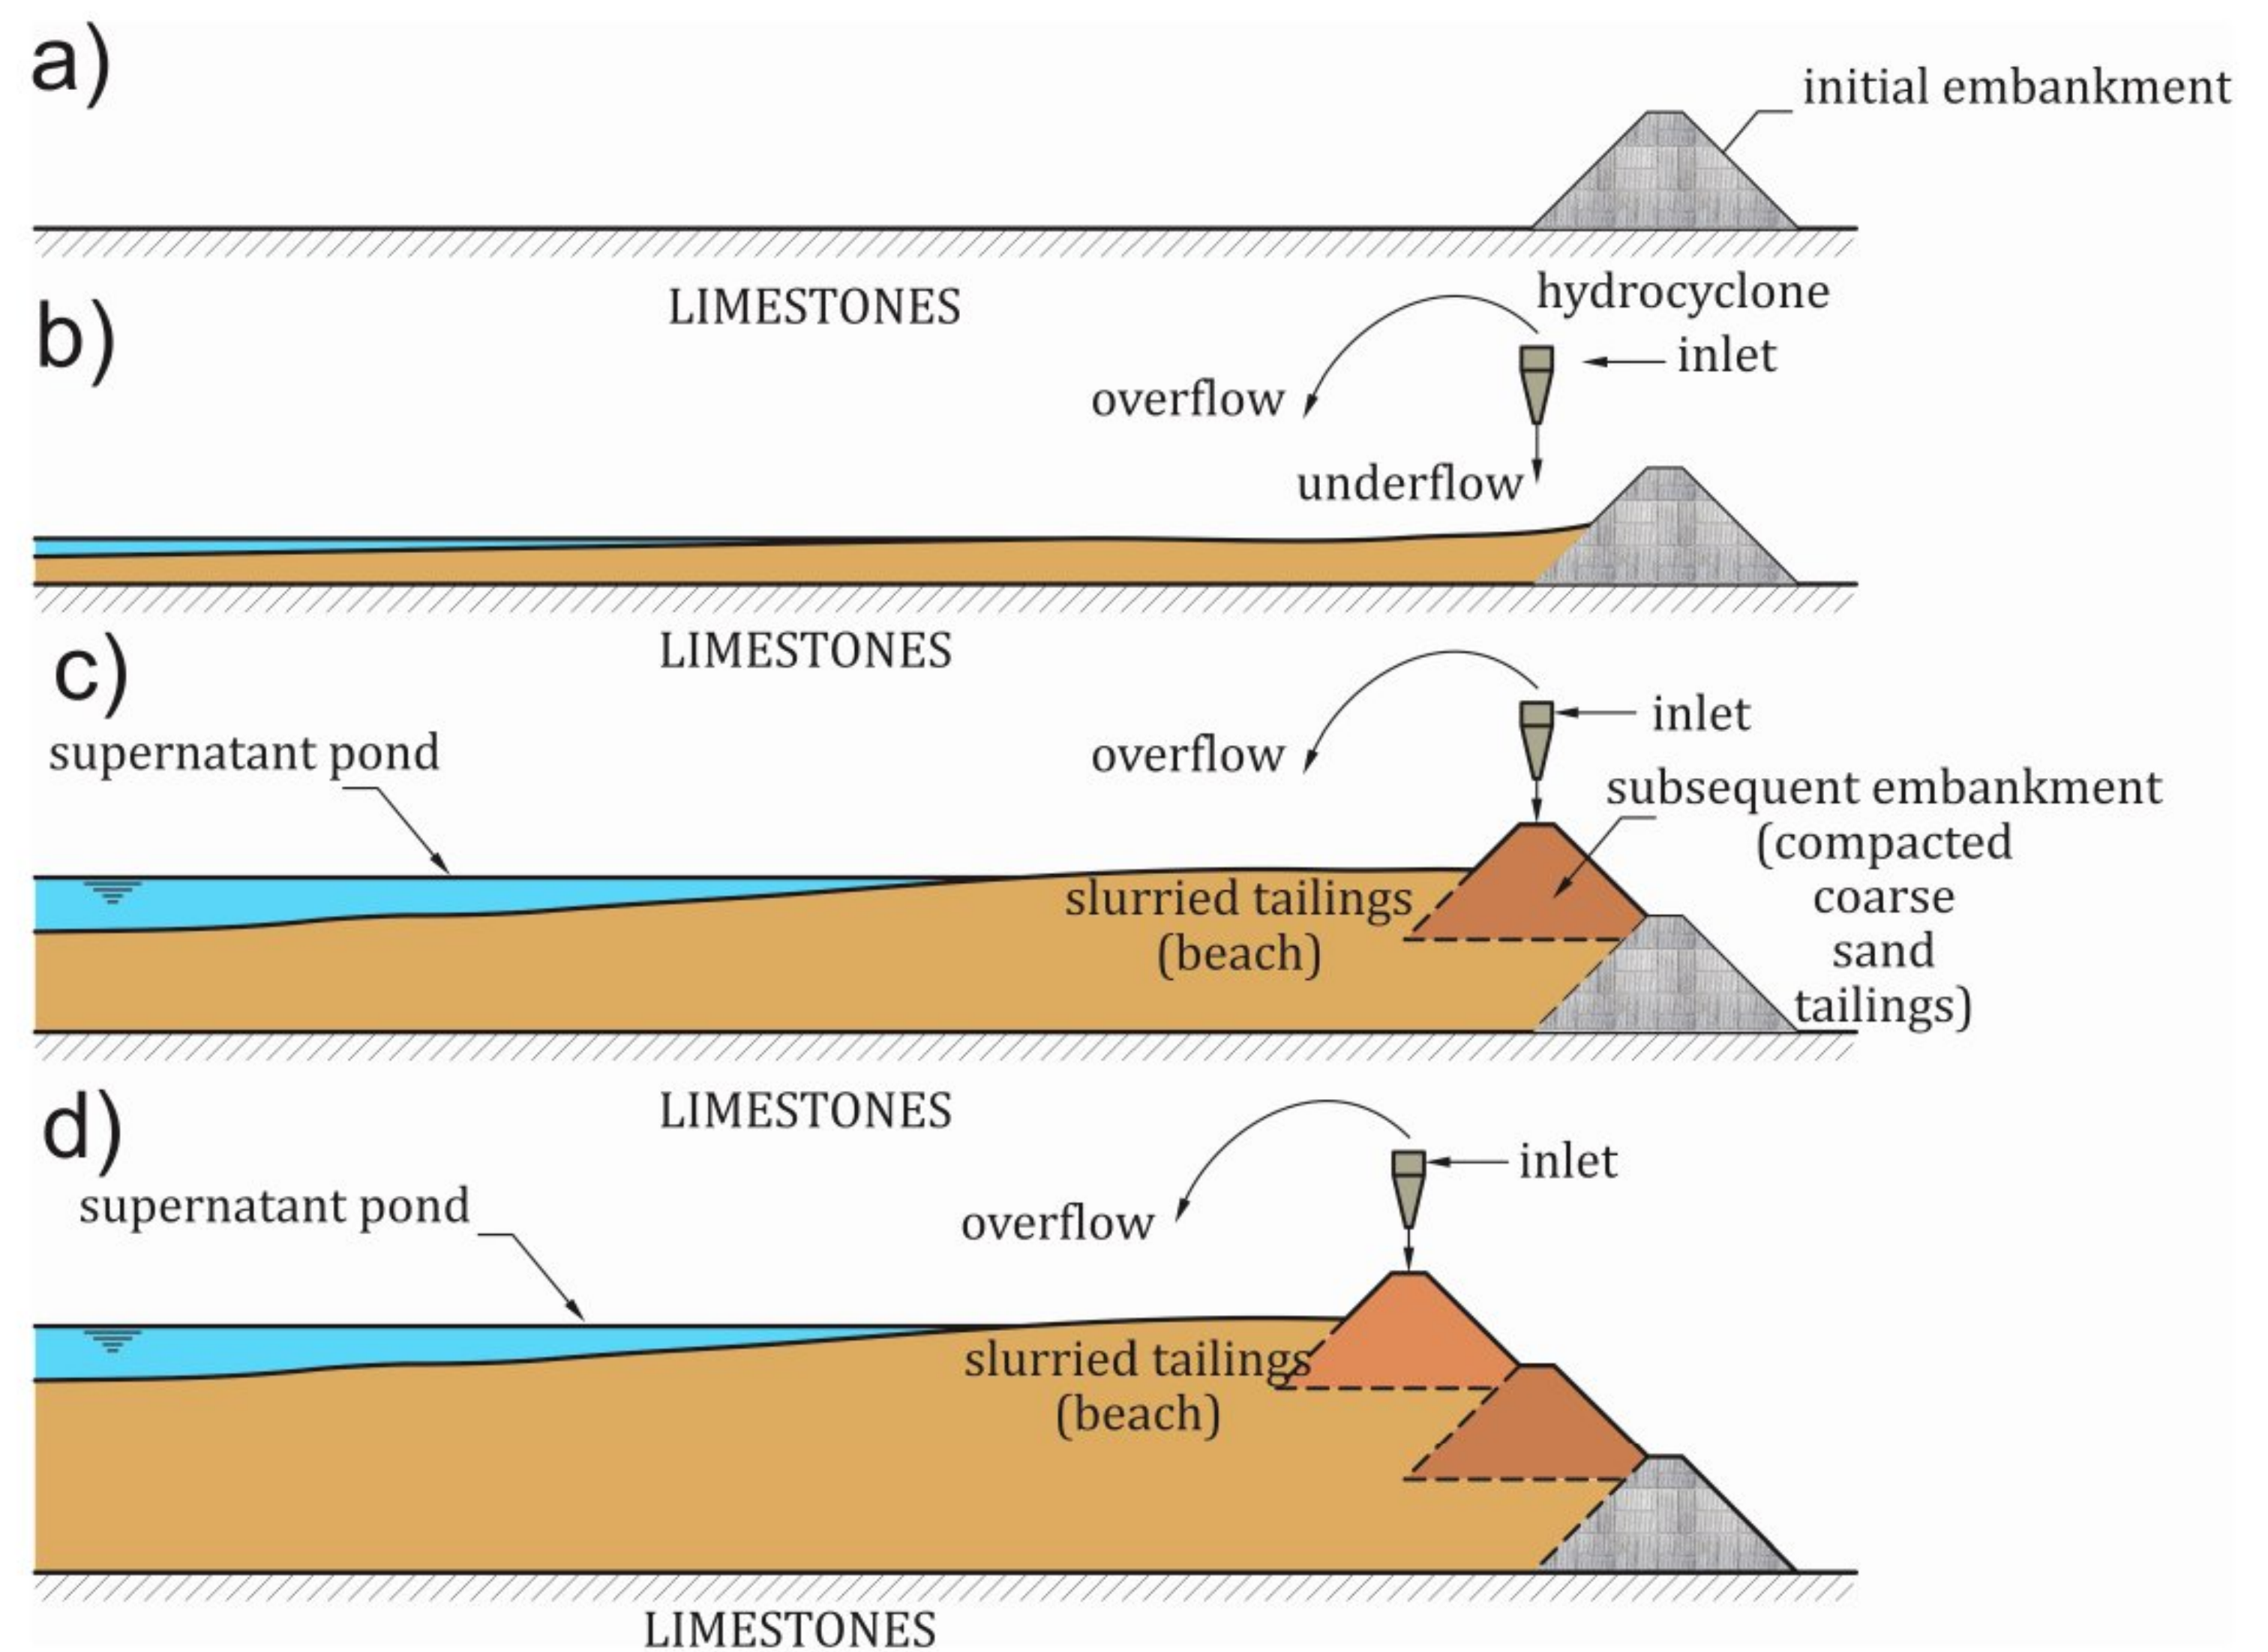
The flotation TSF of the mine “Stolice” represents the valley type of hydraulic TSF, consisting of two fields: eastern and western. It was built up using the introductory method of hydrocyclone sand, which involves the construction of an initial embankment with material from the borrow pit, on which peripheral embankments from the tailings are then added. With this method, the superstructure is built in levels, the height of which

ranges from 3 to 5 m, starting towards the center of the TSF. Every subsequent level rests on the formerly deposited silty tailings, which may negatively impact the stability of the TSF. Due to the segregation and deposition of the material in the form of hydromixtures, a sedimentary lake is formed [5]. The principle of the formation of the flotation TSF of the “Stolice” mine in stages is shown in Figure 2.

Figure 2. The principle of forming the TSF during the operation of the mine “Stolice”: (a) forming of the initial embankment; (b) classification of tailings in the hydrocyclone, during which a subsequent embankment is built out of sand, and the overflow is poured into the storage space; (c) segregation of the deposited tailings and formation of the supernatant pond; (d) the expansion of the TSF by building levels towards the center of the landfill.

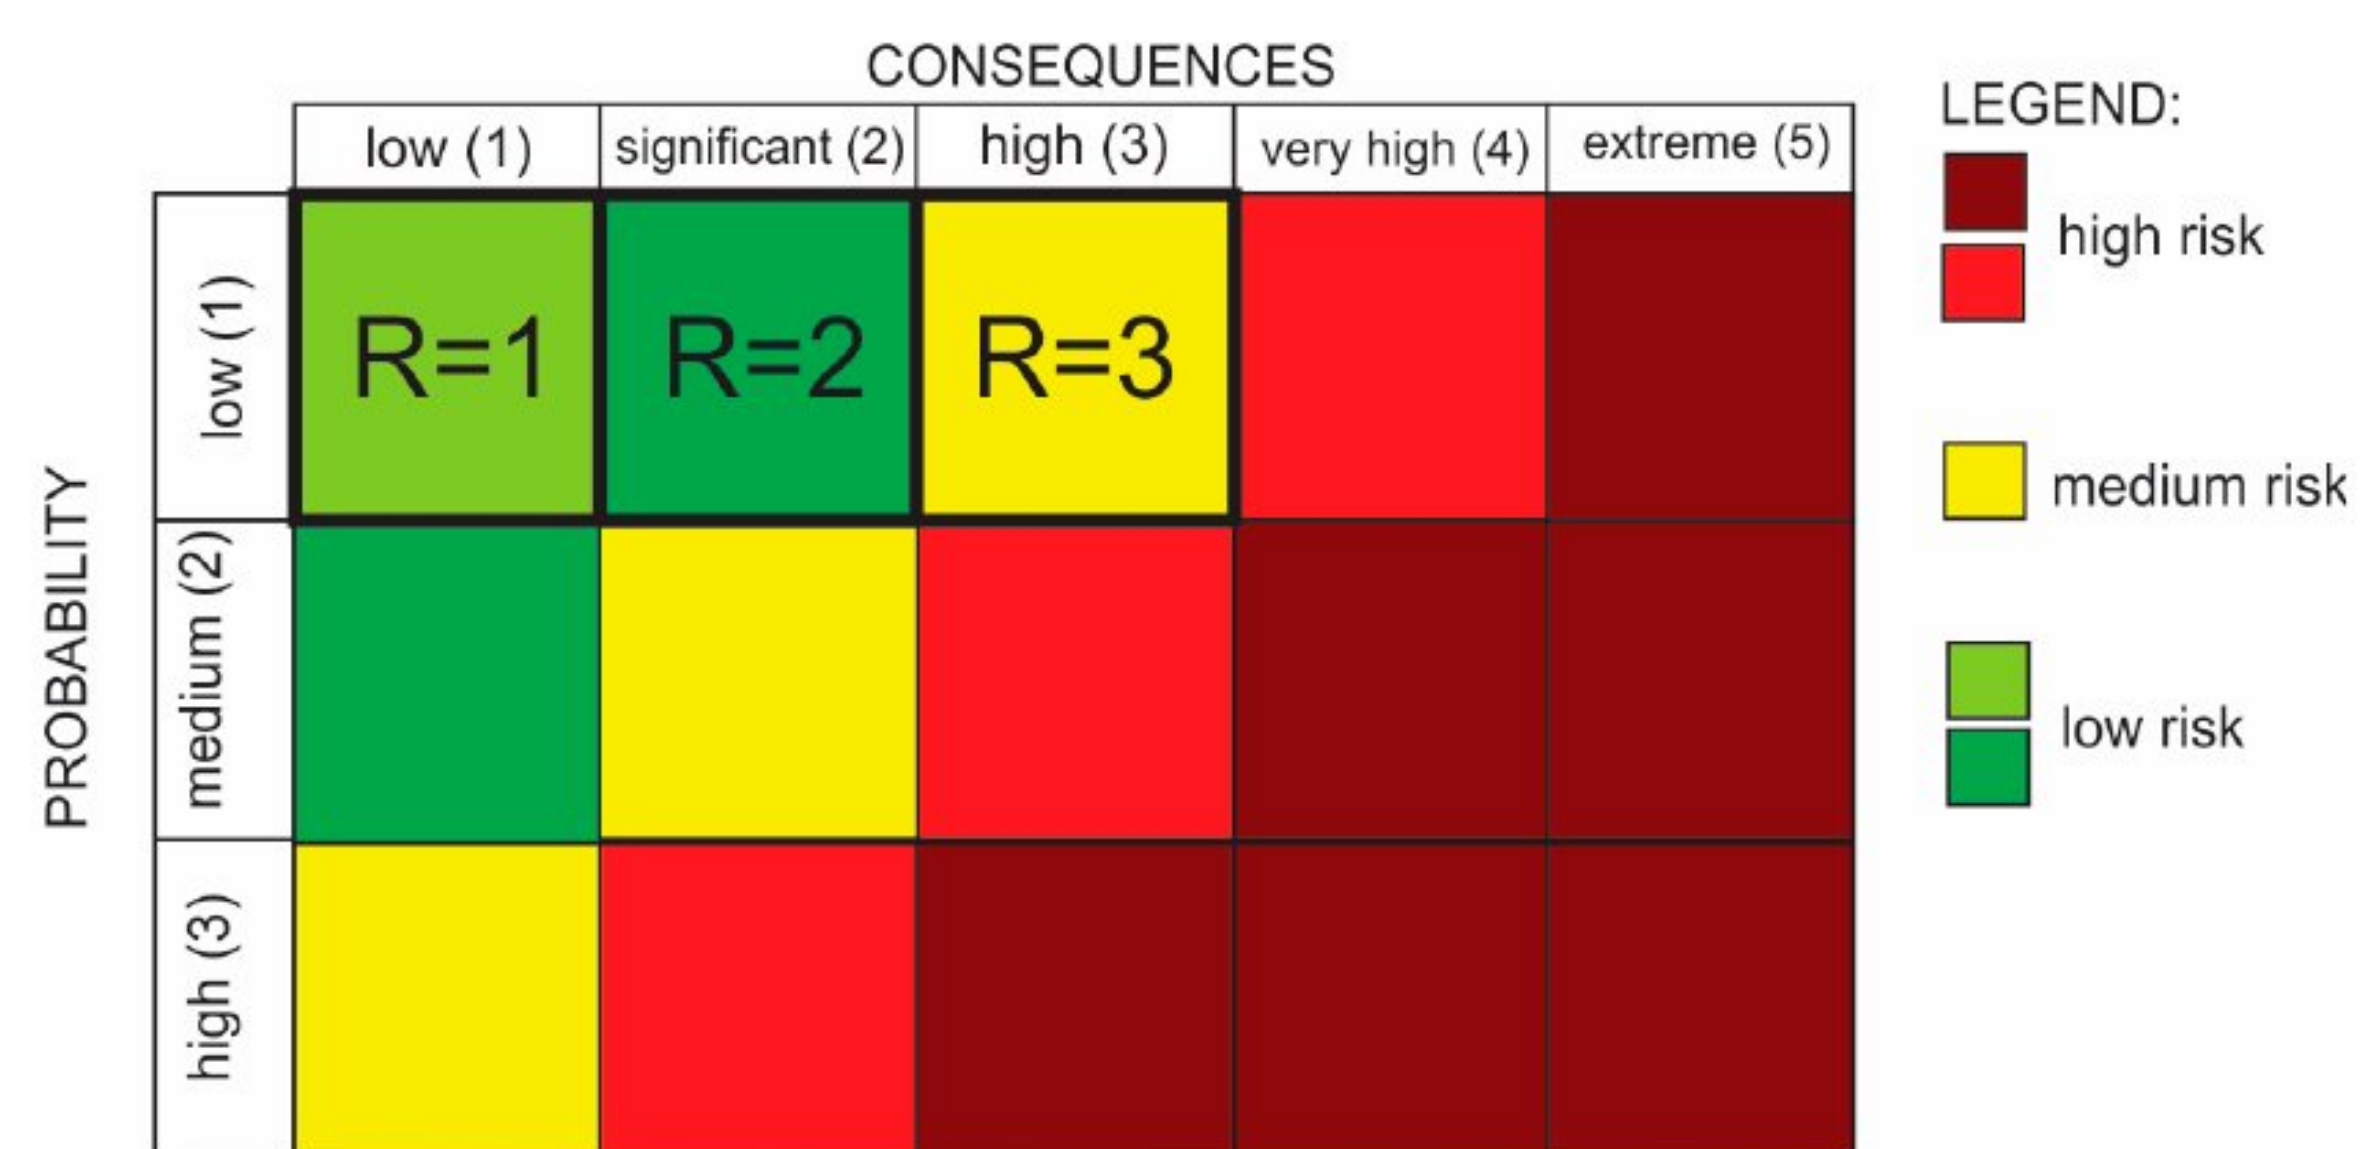
Figure 10. Risk matrix 3 × 5.

when they were assessed as consequences of “low to high” significance. Based on these two parameters, a “low-to-medium” risk level, ranked between 1 and 3, is obtained, which is interpreted as an acceptable risk [34] (Figure 10).
