# Preliminary Risk Assessment of Dam Failure at the Location of the Cukaru Peki Deposit, Bor (Serbia)

Dragana Nišić

This paper aims to assess the preliminary risk of dam failure during the operation of the new copper and gold deposit located in eastern Serbia, which is currently at its design and construction stage.

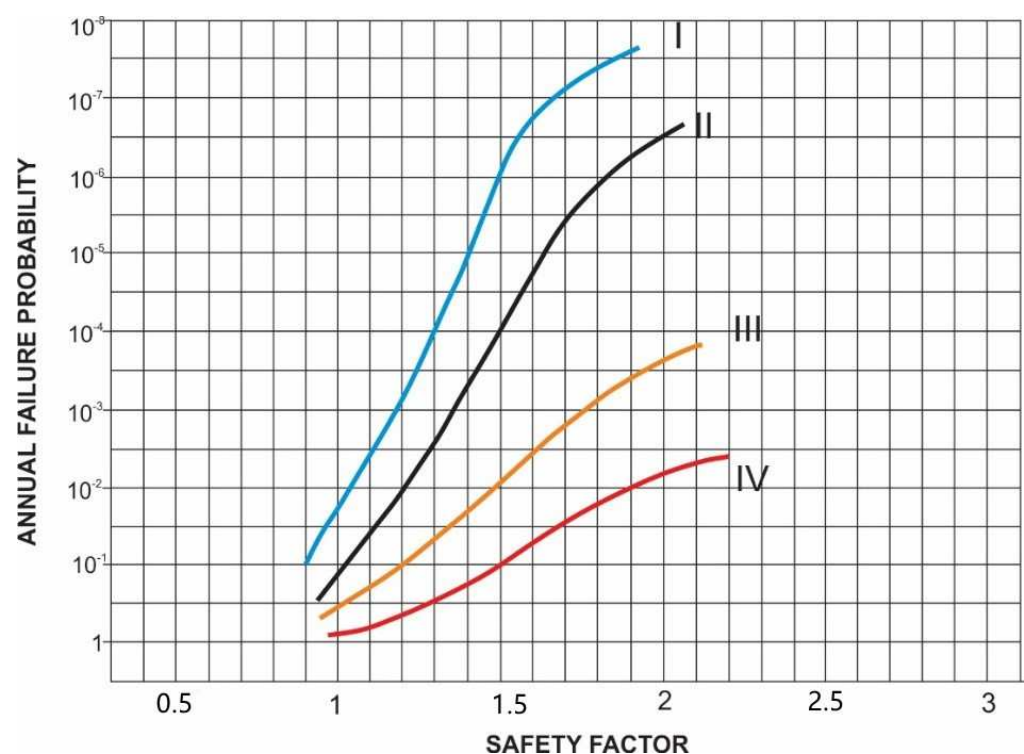
Each category is represented in the diagram by the corresponding curve and the annual probability is obtained when the value on the y-axis is read at the intersection of the values of the safety factor (x-axis) and the facility curve, as shown in Figure 3 [24].

**Figure 3.** The method for the evaluation of annual failure probability [24]. Reproduced with permission from publisher Journal of Geotechnical and Geoenvironmental Engineering, F. Silva, T. W. Lambe, W. A. Marr, *Probability and risk of slope failure*. Journal of Geotechnical and Geoenvironmental Engineering 2008, Vol. 134, No. 12, pp. 1691–1699.

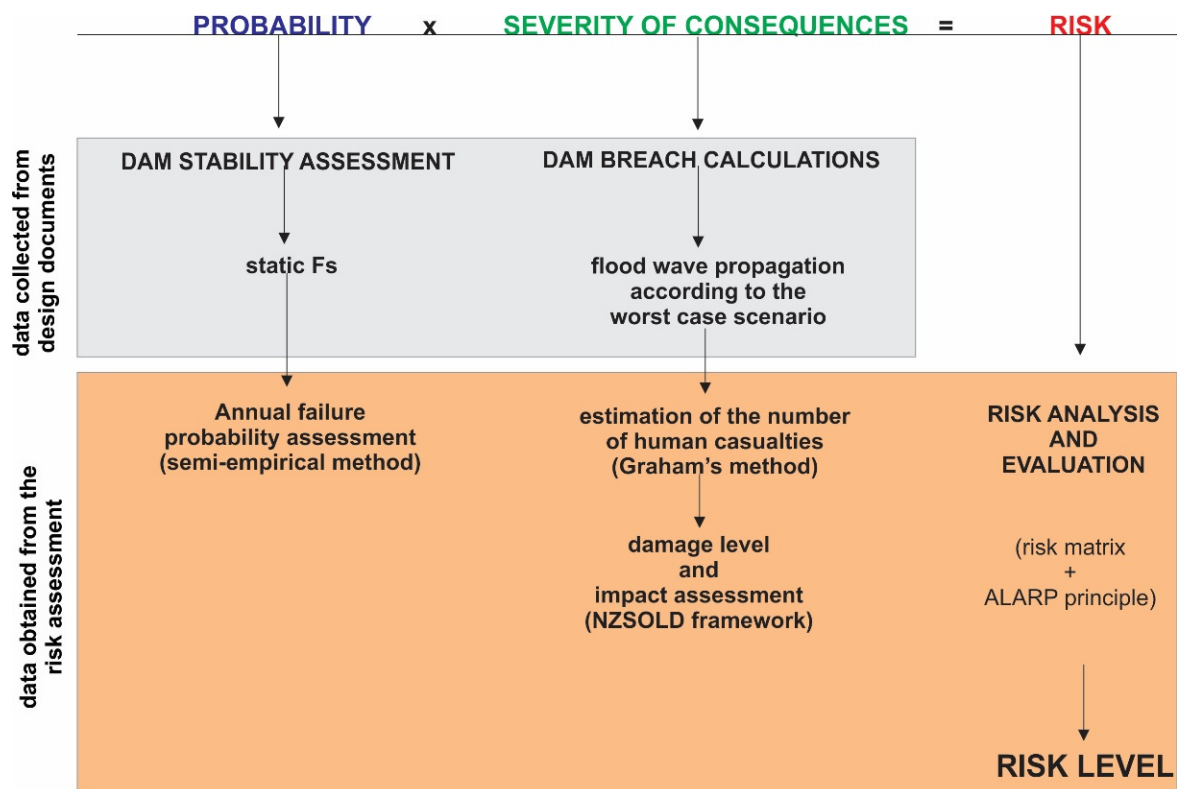
The risk matrix is a technique that is in accordance with the IEC: 31010: 2019 standard [31], and thus very successfully applied to risk analysis. Therefore is ideal for preliminary risk assessment as the input risk parameters can be assigned descriptive values and equivalent numerical values [32]. Failure probability values are proposed in the columns, while levels of consequences are given in the rows. By crossing the values of these two parameters, the level of risk can be obtained. In this paper, the 7 × 7 matrix was applied, from which the mean value can be easily extracted, and which provides a large selection of descriptive levels of probability and severity of consequences. In addition to the risk matrix, the As Low As Reasonably Practical (ALARP) principle was used to evaluate the assessed risk, which is based on the assessment of risk acceptability, and according to which every risk outside the zone of broadly acceptable risk and the zone of unacceptable risk belongs to the zone of conditionally acceptable risk, that is, tolerable risk [33–35]. A scheme of the risk assessment procedure presented in this paper is given in Figure 5.

**Figure 5.** The scheme of the preliminary risk assessment procedure.

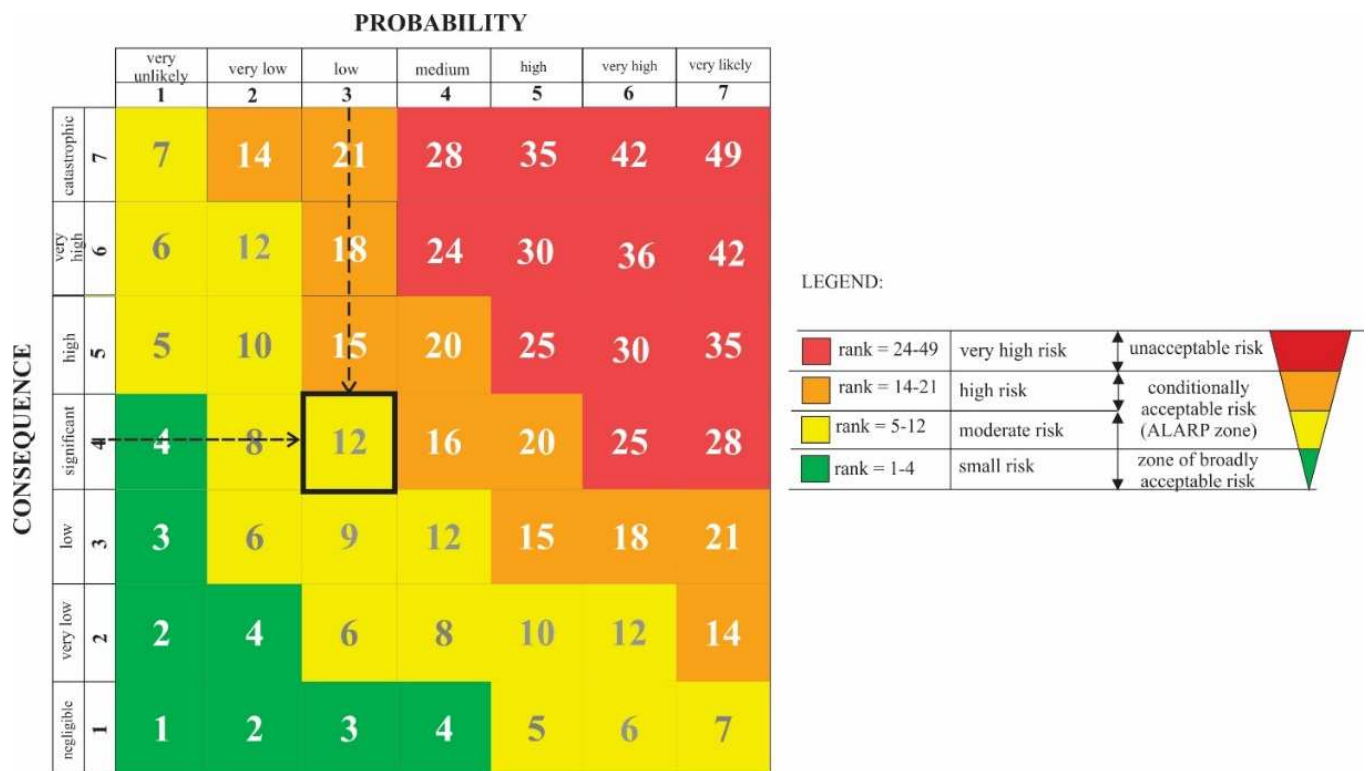
According to the risk matrix  $7 \times 7$ , shown in Figure 10, and based on a low estimated probability of accident, rank 3, and a significant severity of consequences, rank 4, a moderate risk of rank 12 was obtained, which, according to the ALARP, system belongs to a conditionally acceptable or tolerable risk.

Figure 10. 7 × 7 risk matrix.
